Division of Finance & Management

Office of Air, Rail & Transit
700 East Broadway Avenue
Pierre, SD 57501
605.773-3574
dot.sd.gov

SUBJECT: Observation Tour Review

The Department of Transportation (SDDOT) and South Dakota Railroad Board members (the "Board") participated in observation tours of the state-owned railroads to ensure that the track structures and properties are being maintained in accordance with the Board expectations.

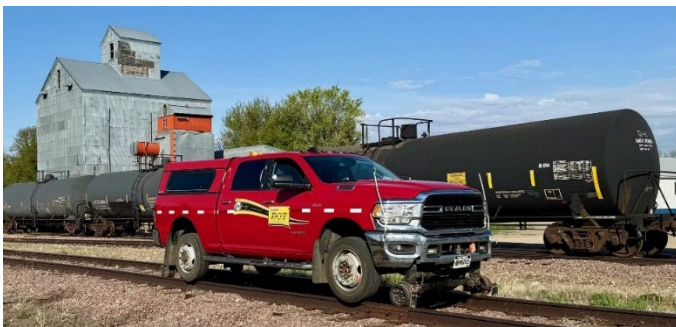
- Claremont (Animal Fat Transload Site): Minor oil spots were observed on the gravel road, with no odor. Approximately 50 railcars were parked on the siding.
- The adjacent old grain elevator has been breached for grain removal, but demolition has not yet started.
- James River near Tacoma Park: The riverbank continues to approach the rail bed but shows no signs of recent erosion or further encroachment.

Photo in Claremont: Tank cars for the animal fat transload. The elevator in background has had the grain removed and the structure is to be removed.

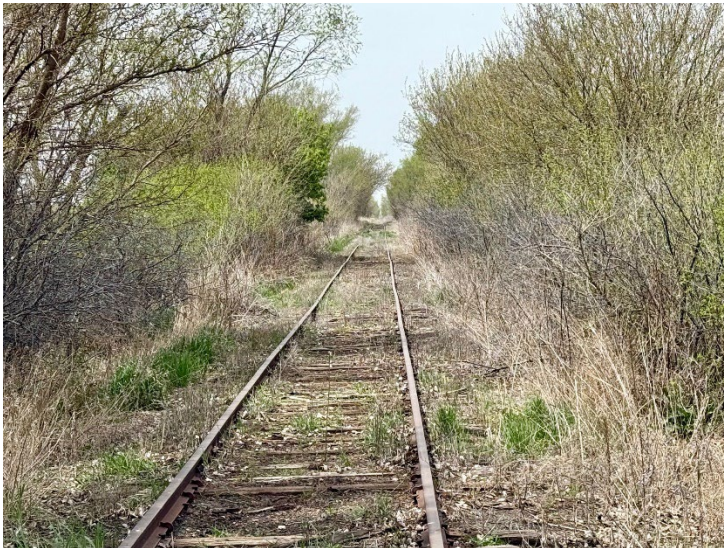
- Obstructions: Six locations had fallen trees; five were cleared, and one required detouring around a one-mile section.
- Vegetation: The corridor was mowed and sprayed last summer. Some tall bushes and trees remain but did not interfere with the hi-rail vehicle. A new crop of thistles was noted in familiar locations.
- Track condition: Generally good for its age, though old ties are still scattered in ditches, and piles of ties in Tabor.

To the left: some areas with encroaching brush.

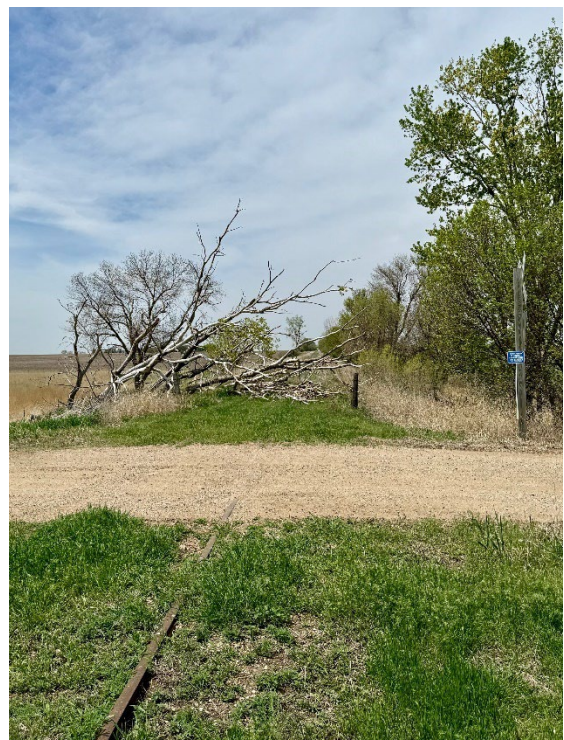
- Tabor Crossings: Four crossings paved over and later milled have not been repaired by Dakota Southern Railway. Temporary patches were applied by the city.
- Highway 25 Crossing: Included in DSRC's maintenance plan; in good condition except for a small pothole in one concrete panel.
- Tyndall Culverts: Cleaned last year by adjacent landowners and remain clear of silt. A new six-foot-wide cut in the earthen dike on the south side of the rail corridor has been opened, enabling natural water drainage to adjoining land.

To the right: gravel on crossing, trees across railroad and young thistle plants starting to grow.

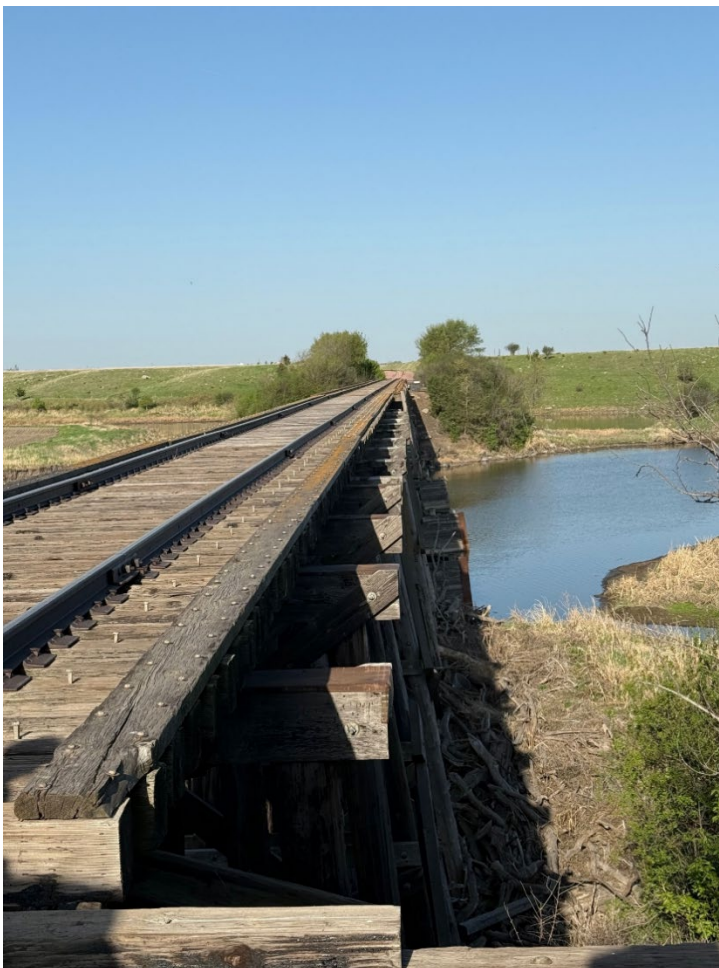
- Track condition: Good overall, with more than adequate ballast, effective weed control, and a manageable number of bad ties. Minor humps were observed but are not considered defects.
- Bridge condition: The large bridge east of the James River is in good condition. The recent riprap installation on the east approach is stable and holding well. There is some drift under the east side.

Yale line bridge (photo below) in good condition, some drift below the bridge.
