# **Division of Finance & Management**

SUBJECT: Observation Tour Review

Railroad board members participated in observation tours of the state-owned railroads May 7 - 9. The purpose of these tours is to ensure the track structure and properties are being maintained in accordance with the State Railroad Board expectations.

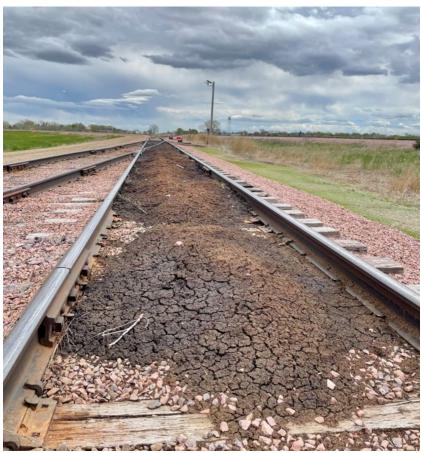
The track is still in like new condition. Vegetation control looks good. There are still two large piles of grain in the gage section from last year, they are now rotted and might cause some water damage to the ties below.

Image of one location with old, spilled grain.

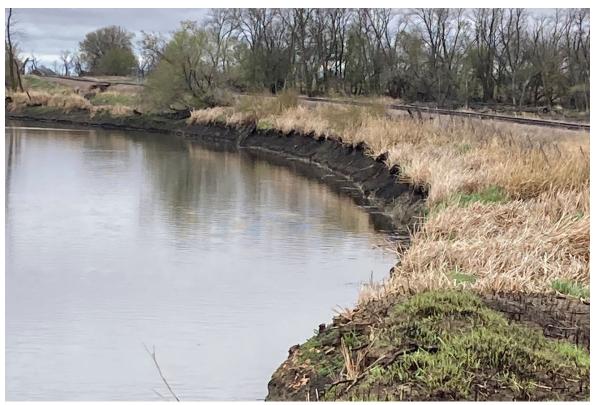
Eroding bank that is moving to within 18 feet of RR ties

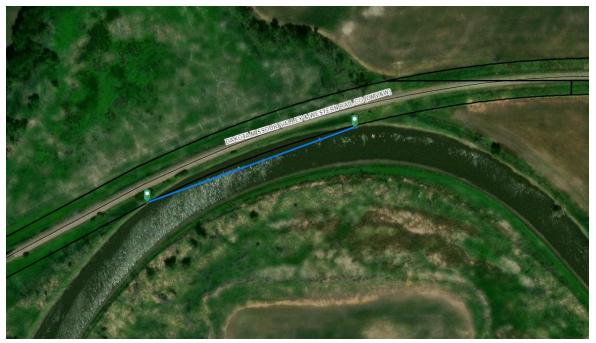
Satellite image showing approximately 600 feet of riverbank eroding close to the railroad grade.
