Transportation Commission

Bridge Scour Design Considerations

Steve Johnson, PE SDDOT Chief Bridge Engineer

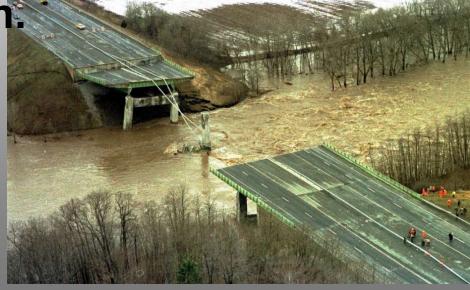
Schoharie Creek Bridge

- Collapsed April 5, 1987 due to bridge scour killing ten people.
- Prompted improvement in bridge design.

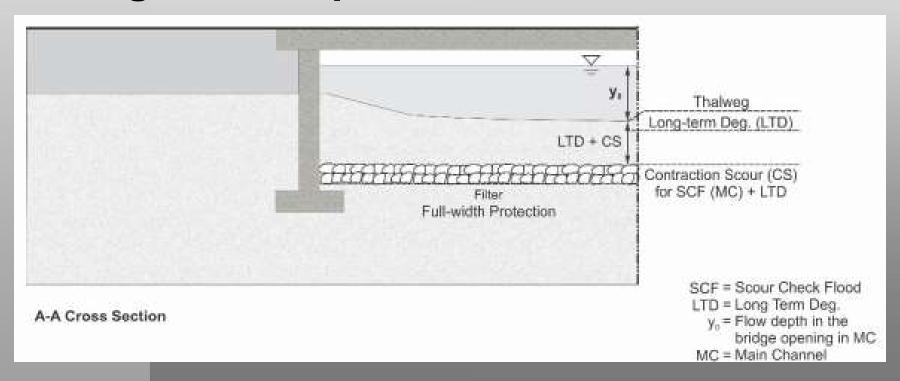
Revised Abutment Protection Recommendations

Countersink apron below long-term degradation plus contraction scour

- Some structures no impact
- Increased depth of countermeasures
- Increased structure length
- Increased substructure depth
