D & I Railroad Summary of Flood Damages April 2019

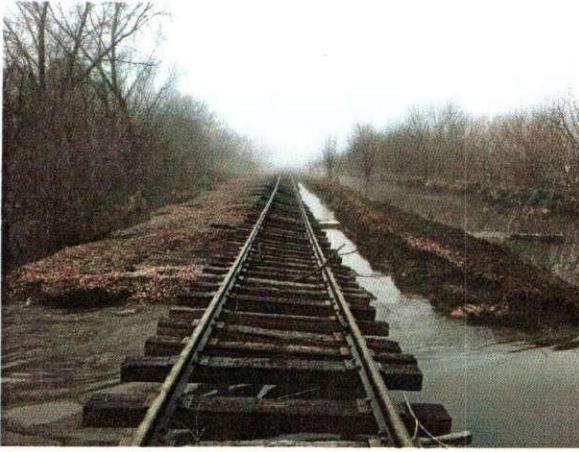
MP 2.9

MP 2.81 to MP 4.83 (North of Elk Point)

- 4200 tons of track ballast
- 4000 tons of rip rap
- 1000 ties

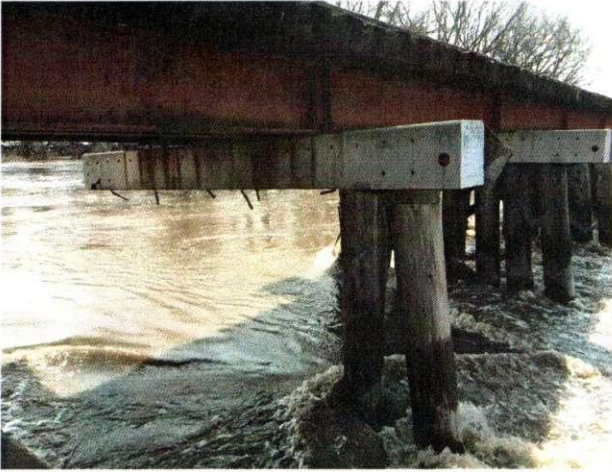
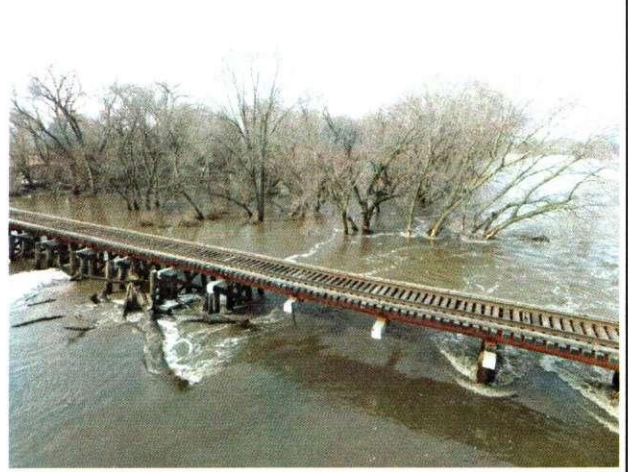
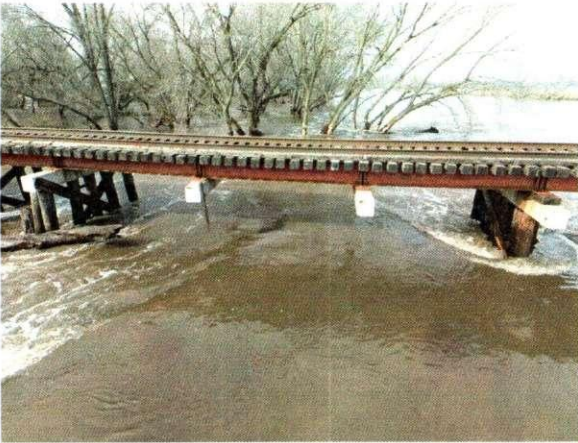
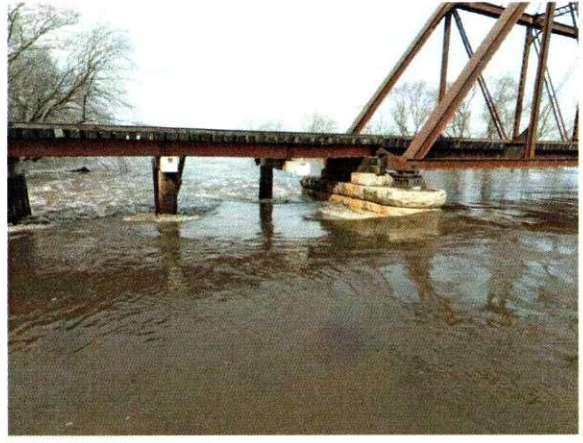
T 572—Dawson Bridge (North of Hawarden)

- Replace 20 broken piling
- Replace 6 pile caps
- Bracing repairs
- Will need to build a causeway to accomplish repairs

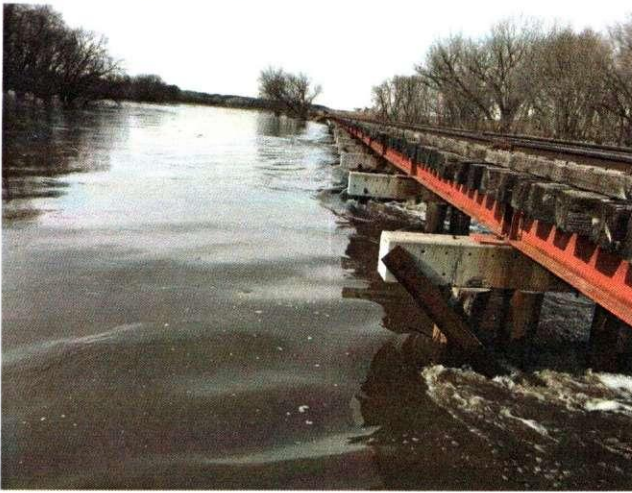
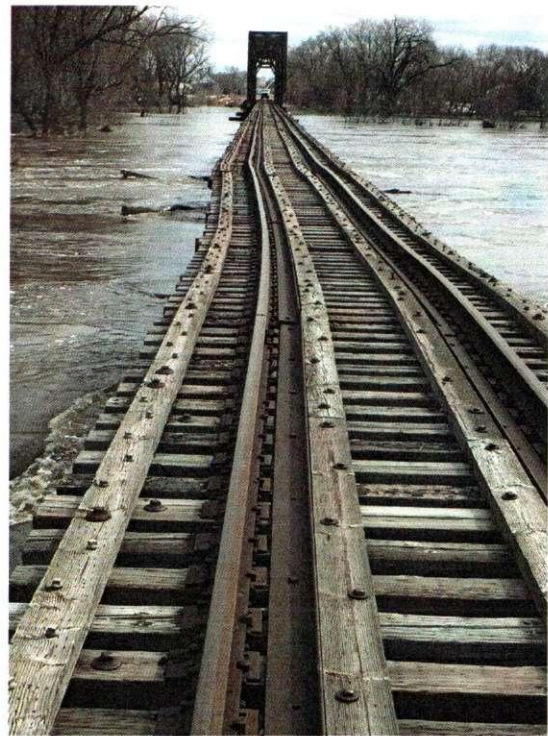
T 594—Hudson Bridge (1 mile North of Hudson)

- 20 piling broken or moved
- Bracing repairs
- River levels have not allowed for a full inspection

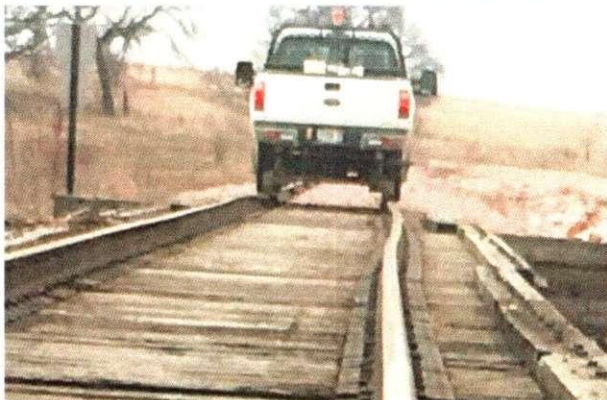
T 598—(2 miles North of Hudson)

- Girder bearing displaced
- River levels have not allowed for a full inspection

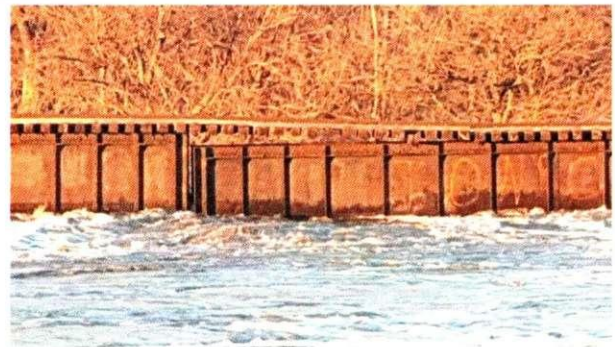
T 2601—Beresford Bridge (At Hawarden)

- Top deck girder span displaced from bearing

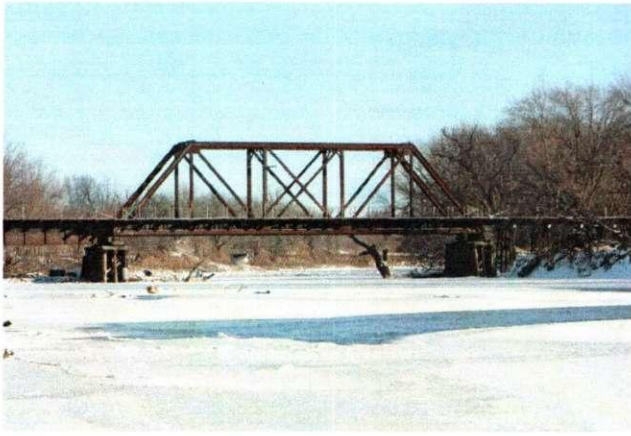
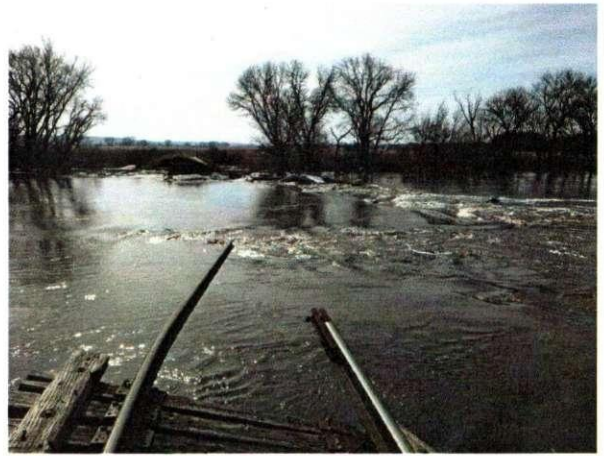
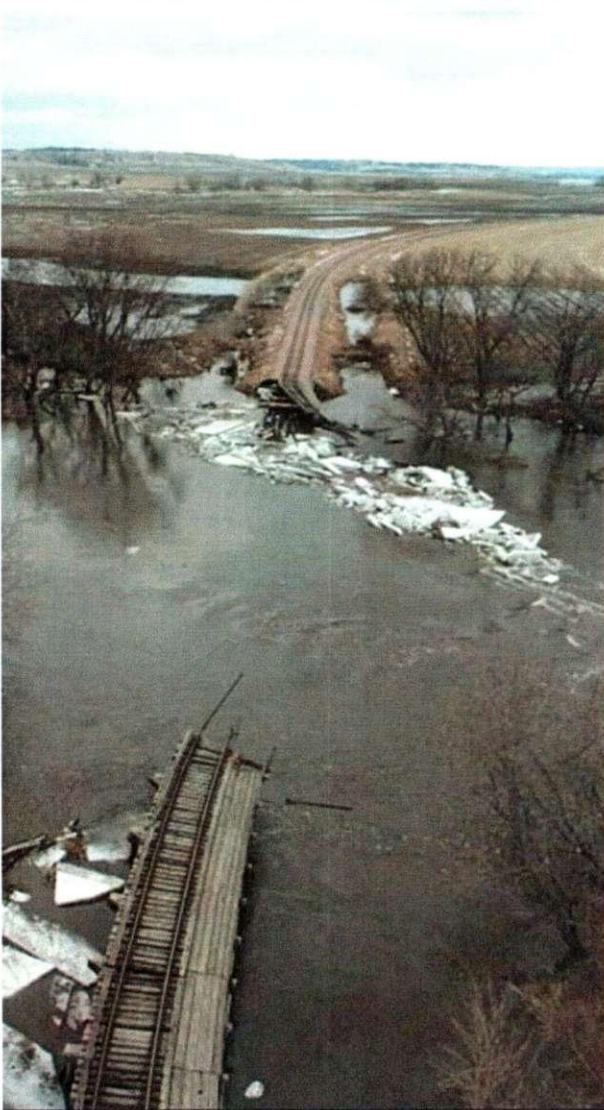
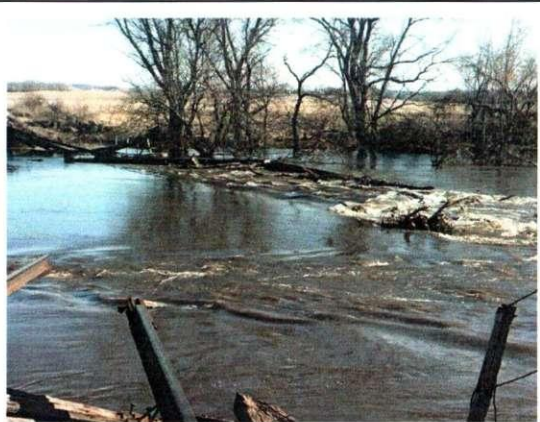
T 648—Canton Bridge (At Canton)

- Entire truss and girder structure pushed into the water
