# Homestake/Richmond Hill 2018 Employment and Contributions

# Homestake Mine Open Cut Review

# Homestake Mine 2018 Activities

DECEMBER 2018 SEMI-ANNUAL  
GEOTECHNICAL MONITORING REPORT  
LEAD, SOUTH DAKOTA

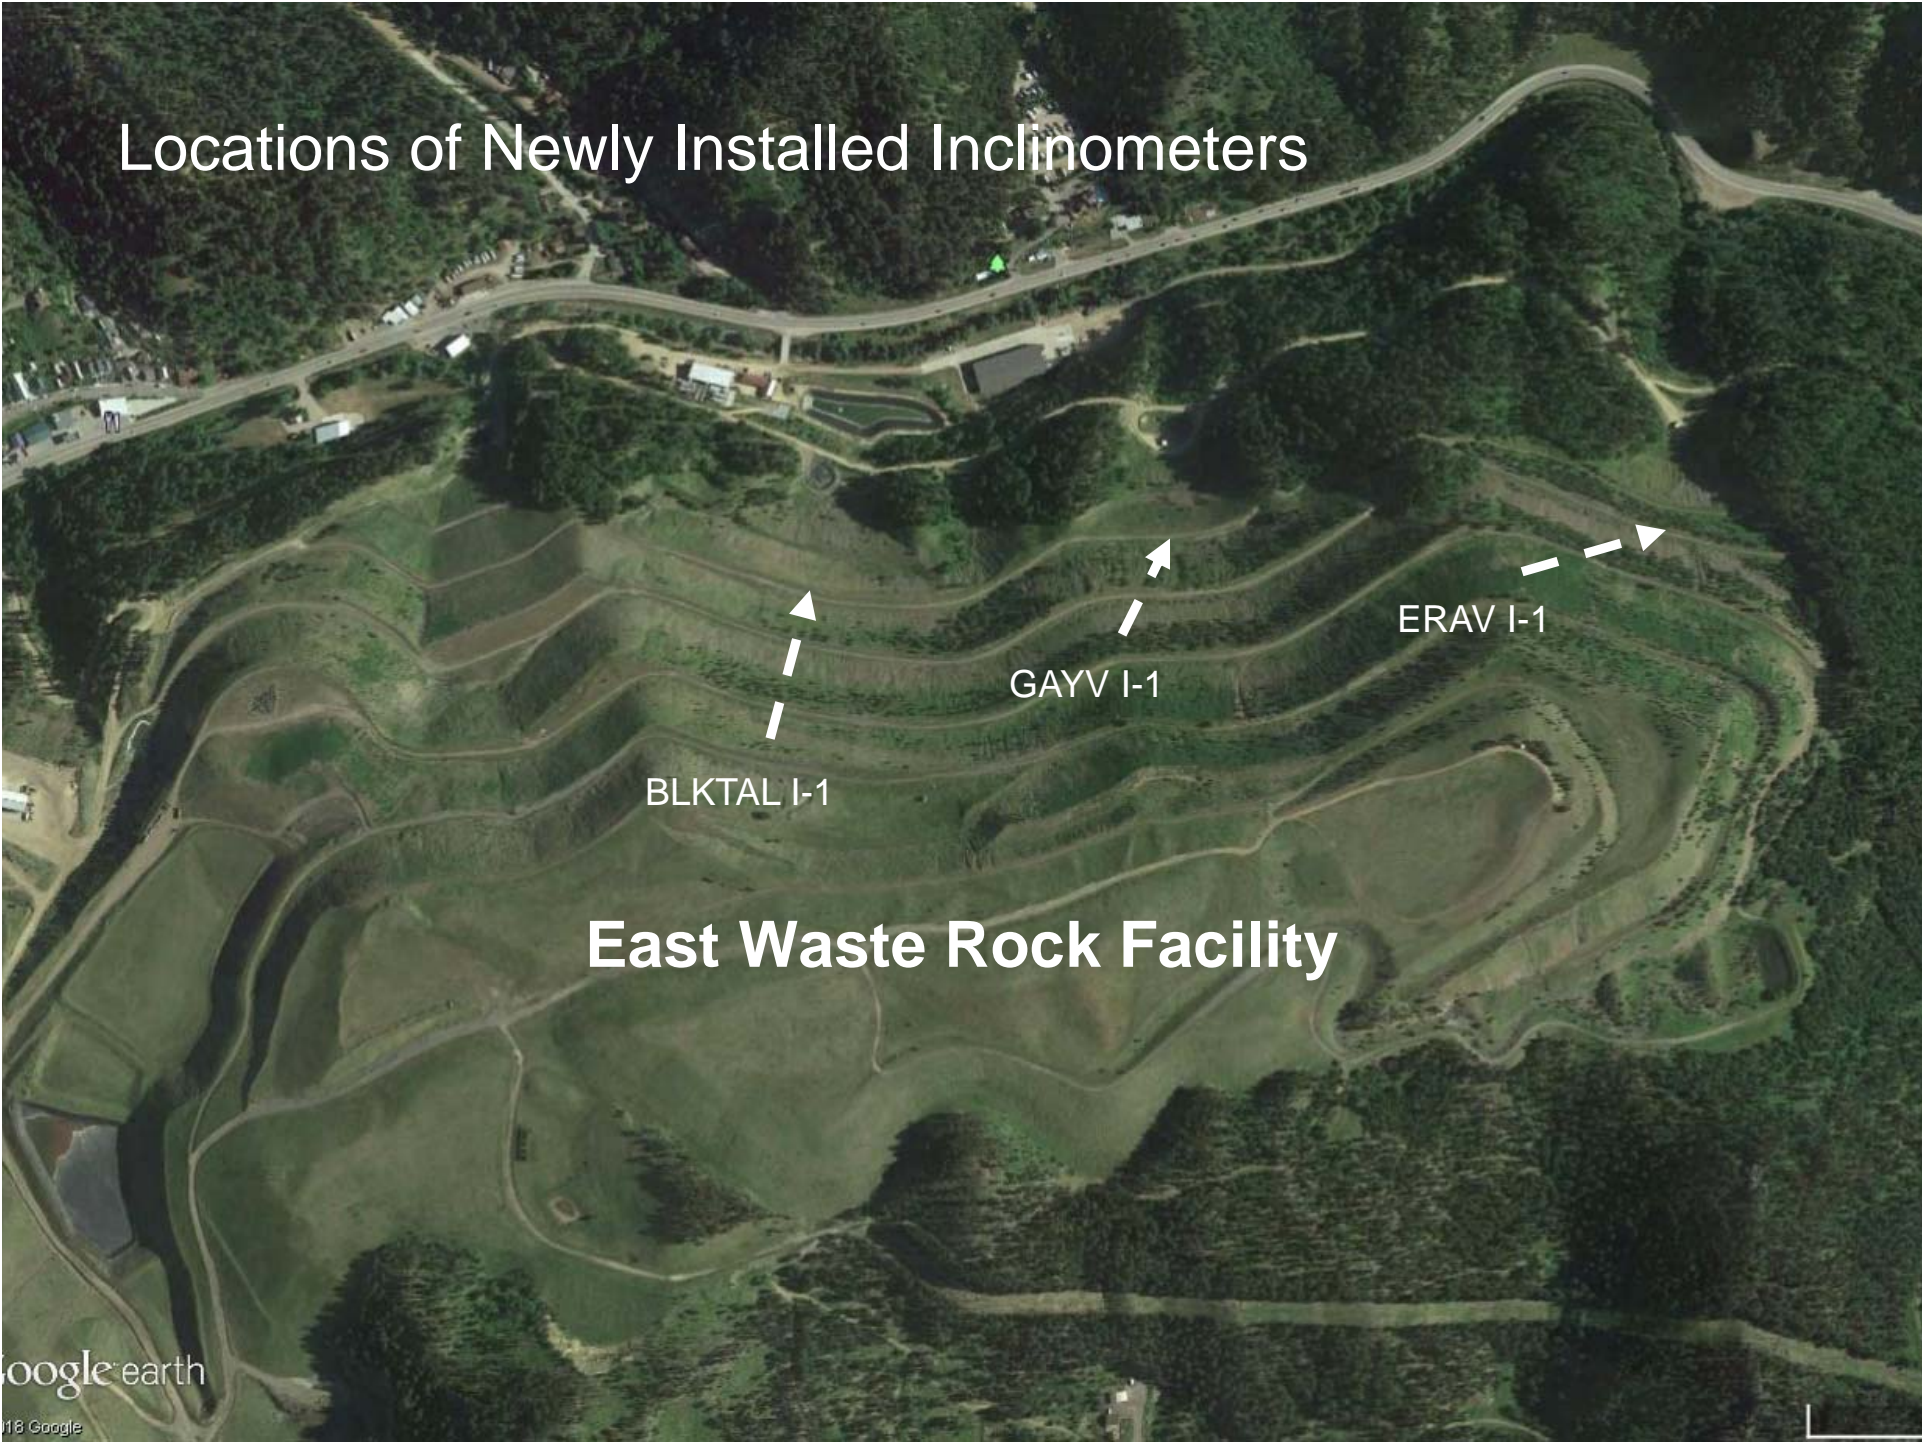
# Locations of Newly Installed Inclinometers

New inclinometers installed at EWRDF include:

- ERAV I-1 in East Ravine (5100 ft. bench)
  - 150 ft. depth

- GAYV I-1 in Gayville Gulch (5000 ft. bench)
  - 151 ft. depth with vibrating-wire piezometer

- BLKTAL I-1 Blacktail Gulch (5000 ft. bench)
  - 199 ft. depth

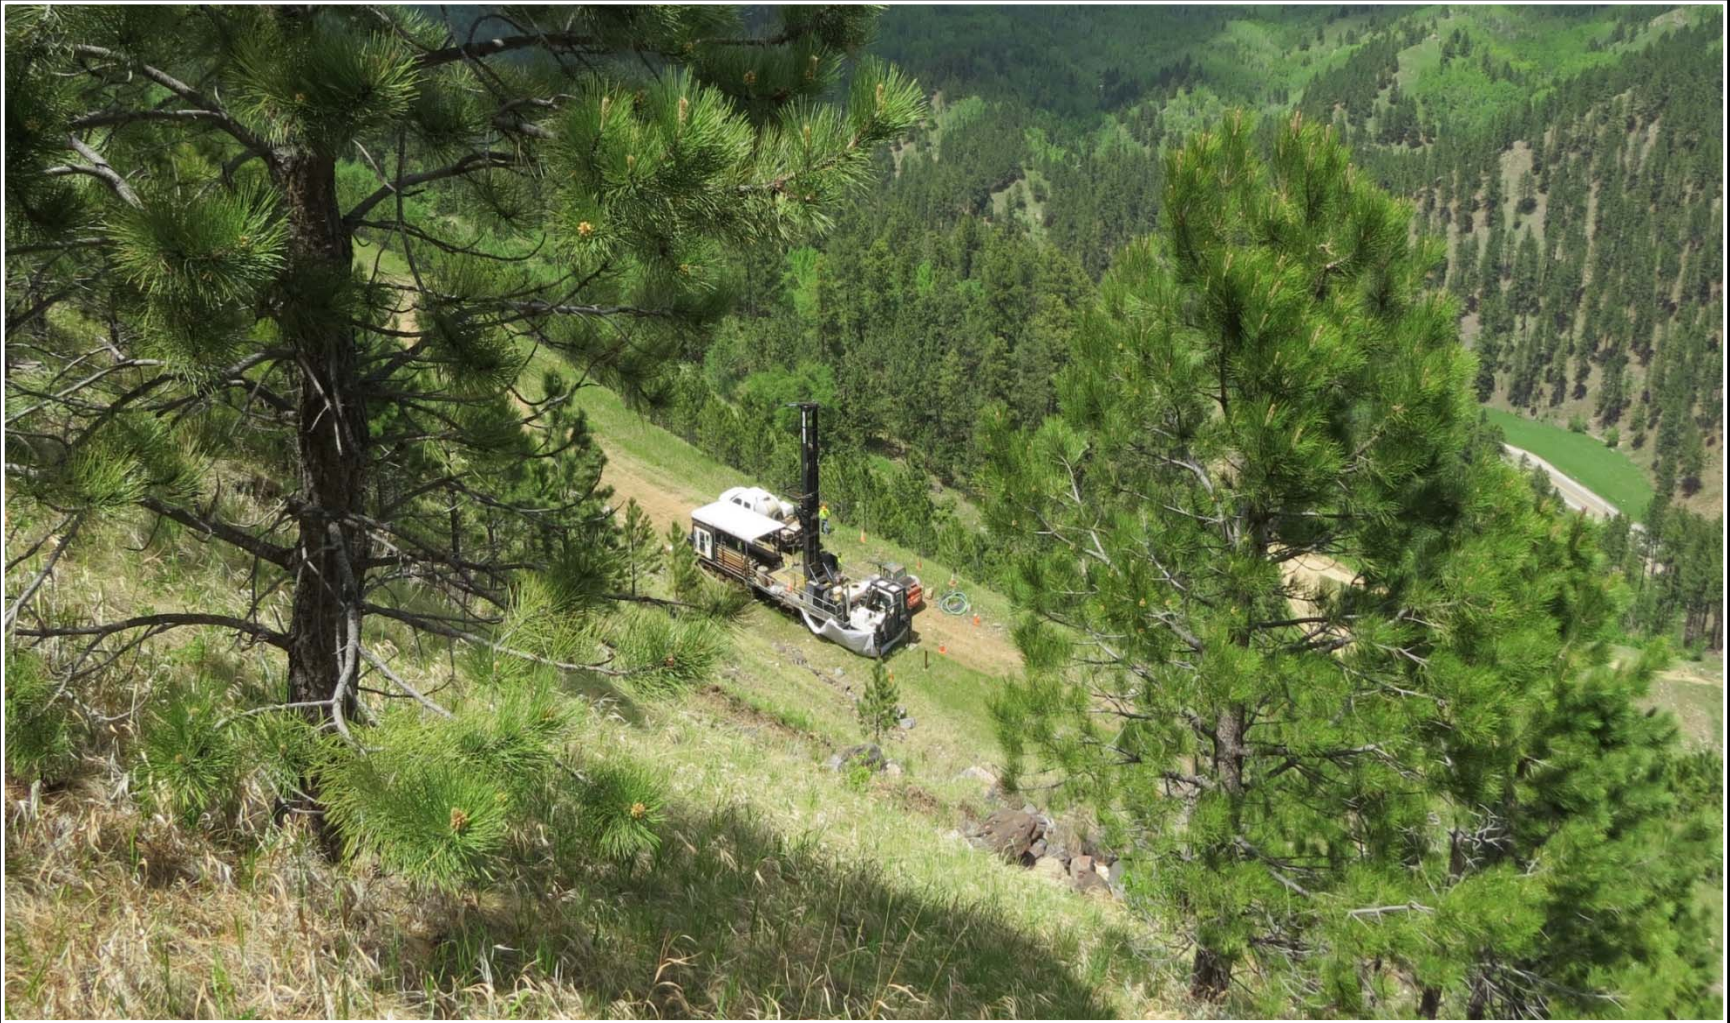
**Drilling ERAV I-1 Inclinator**

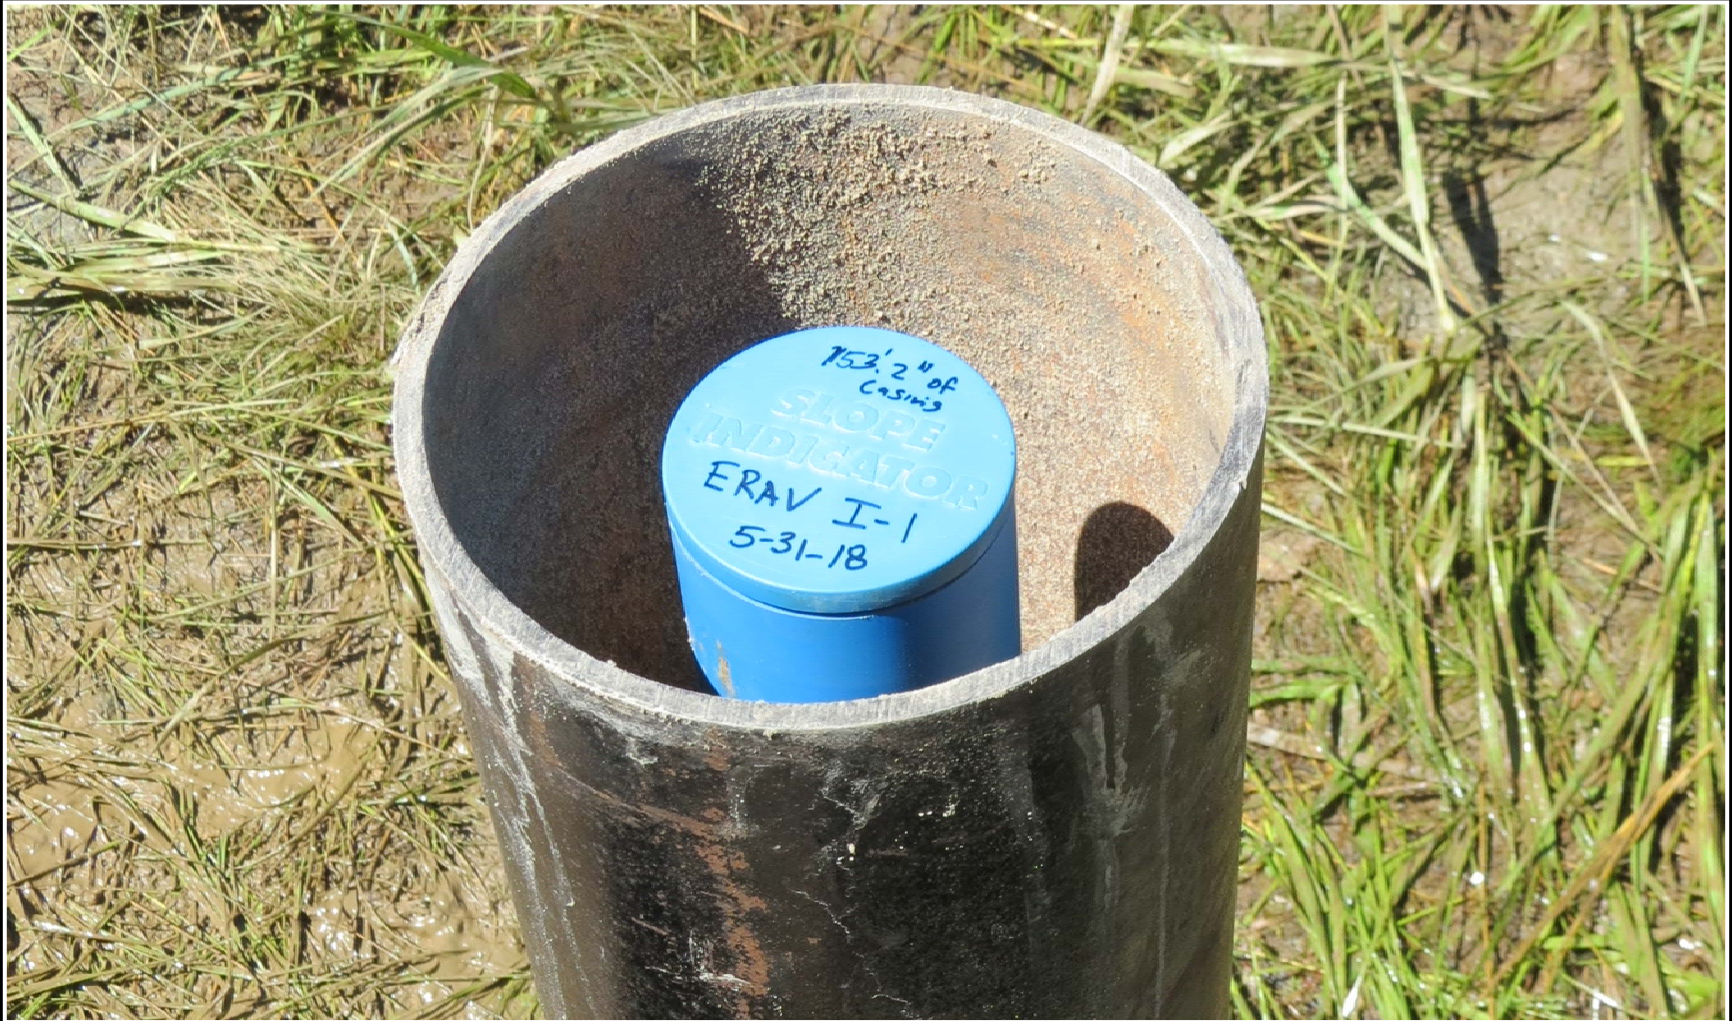
**Installed Inclinometer**

- Piezometers
  - No significant buildup of water pressures in waste rock facility
- Inclinometers
  - The new inclinometers installed in June 2018 have indicated only 0.1 inches of northward surficial movement with no shear displacement
- Visual Inspections
  - Tension crack at 5100 bench at Gayville is the only surficial change observed. No significant change to crack within last year
  - Tension crack appears to be associated with topsoil slumping

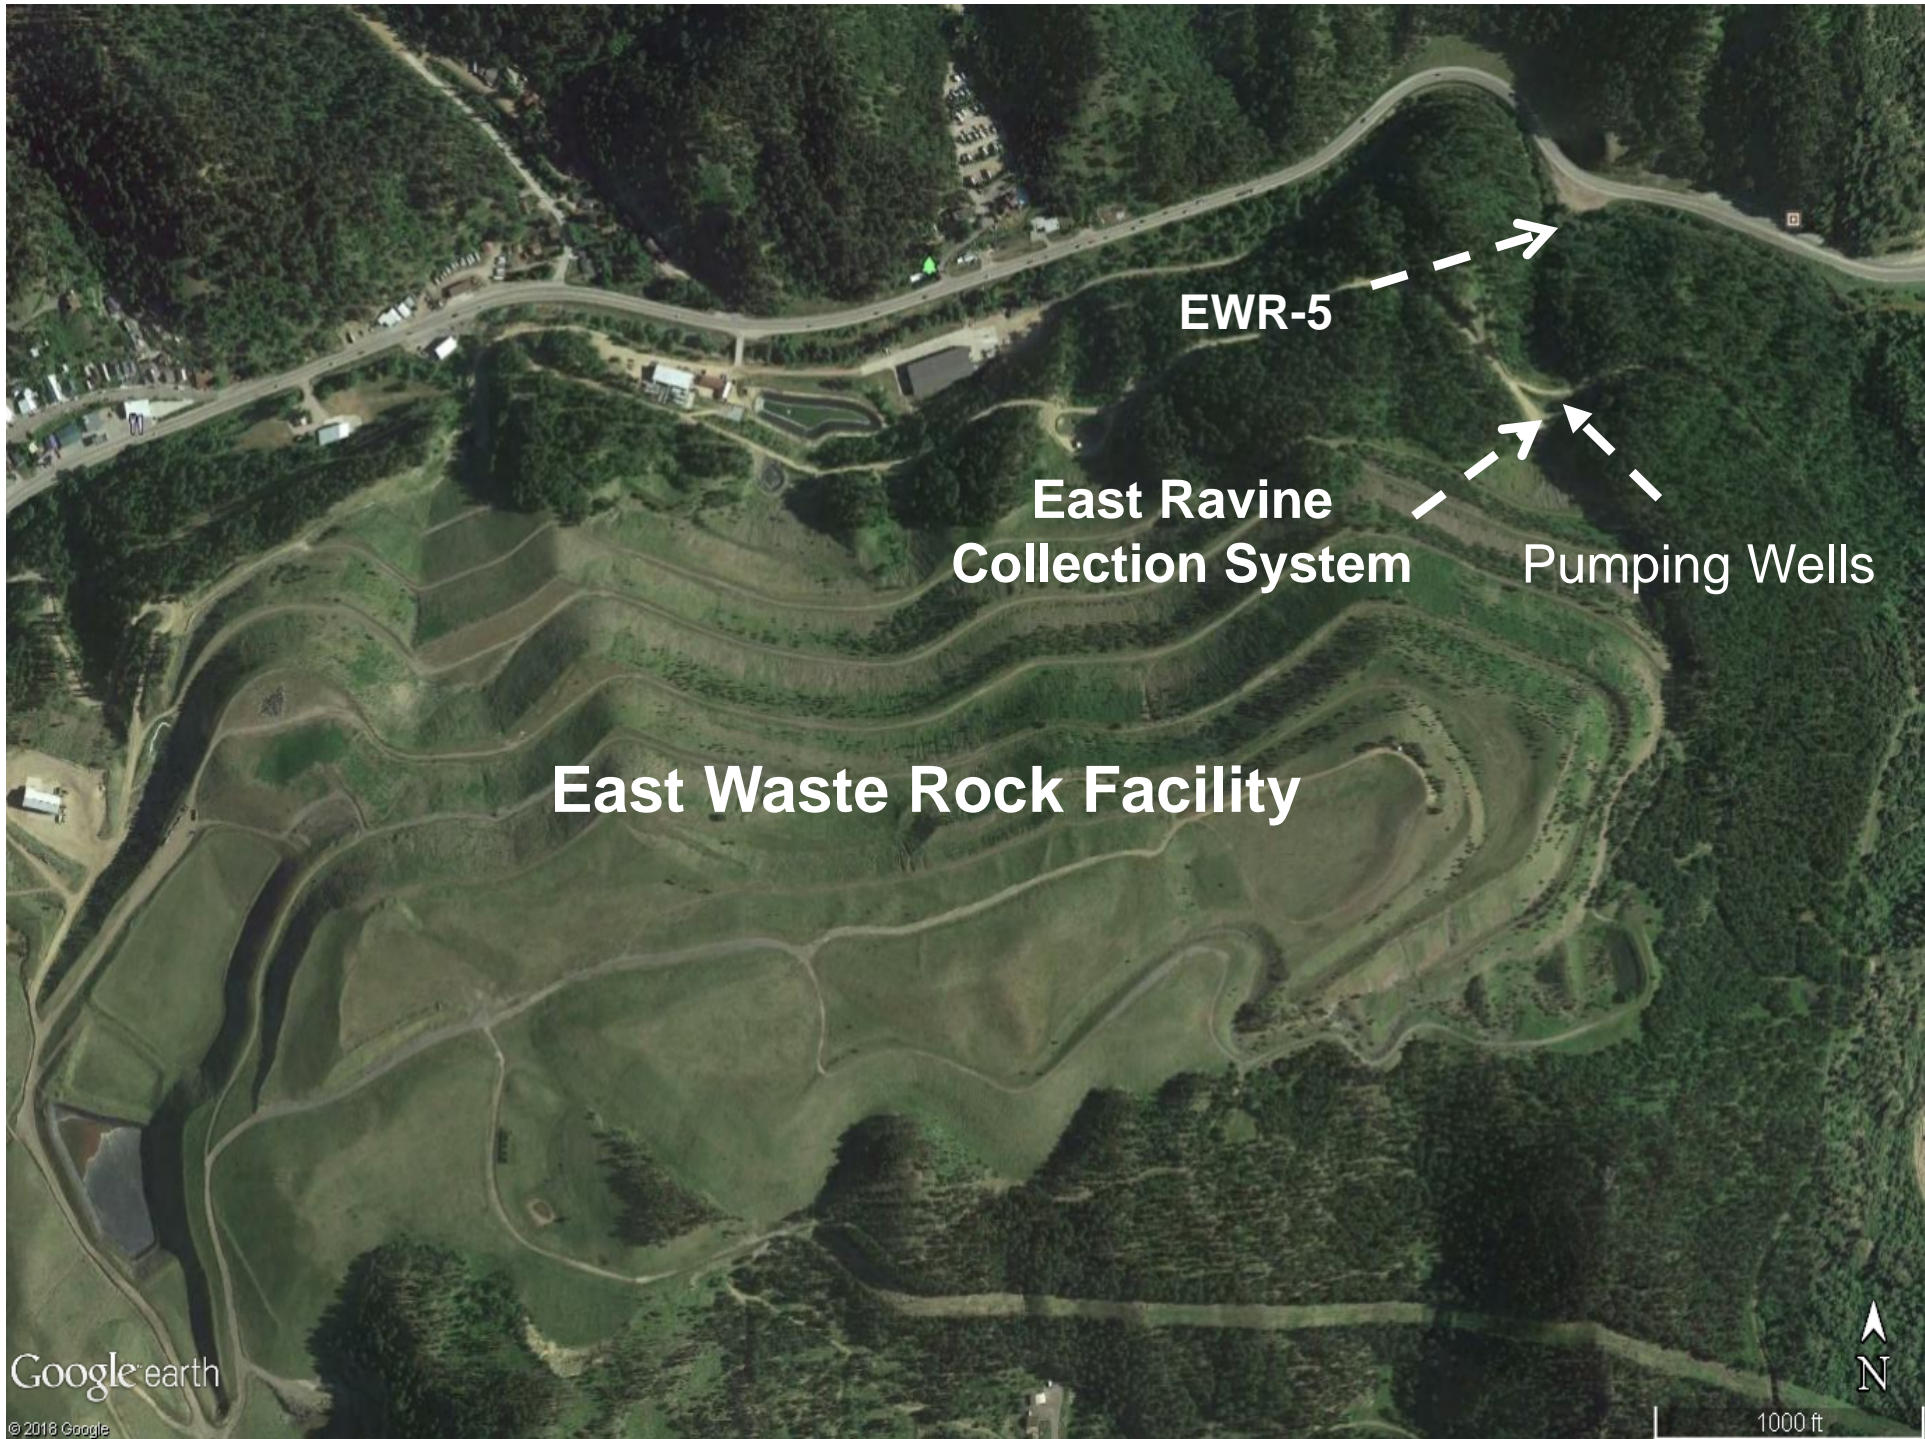
- Two additional pumping wells (GW-6 and GW-7) were drilled in 2017
- Pumps and piping from new wells to collection system installed in 2017 and 2018
- Pumps operational in 2018
- Continuing to evaluate effectiveness of system

Pumping Wells

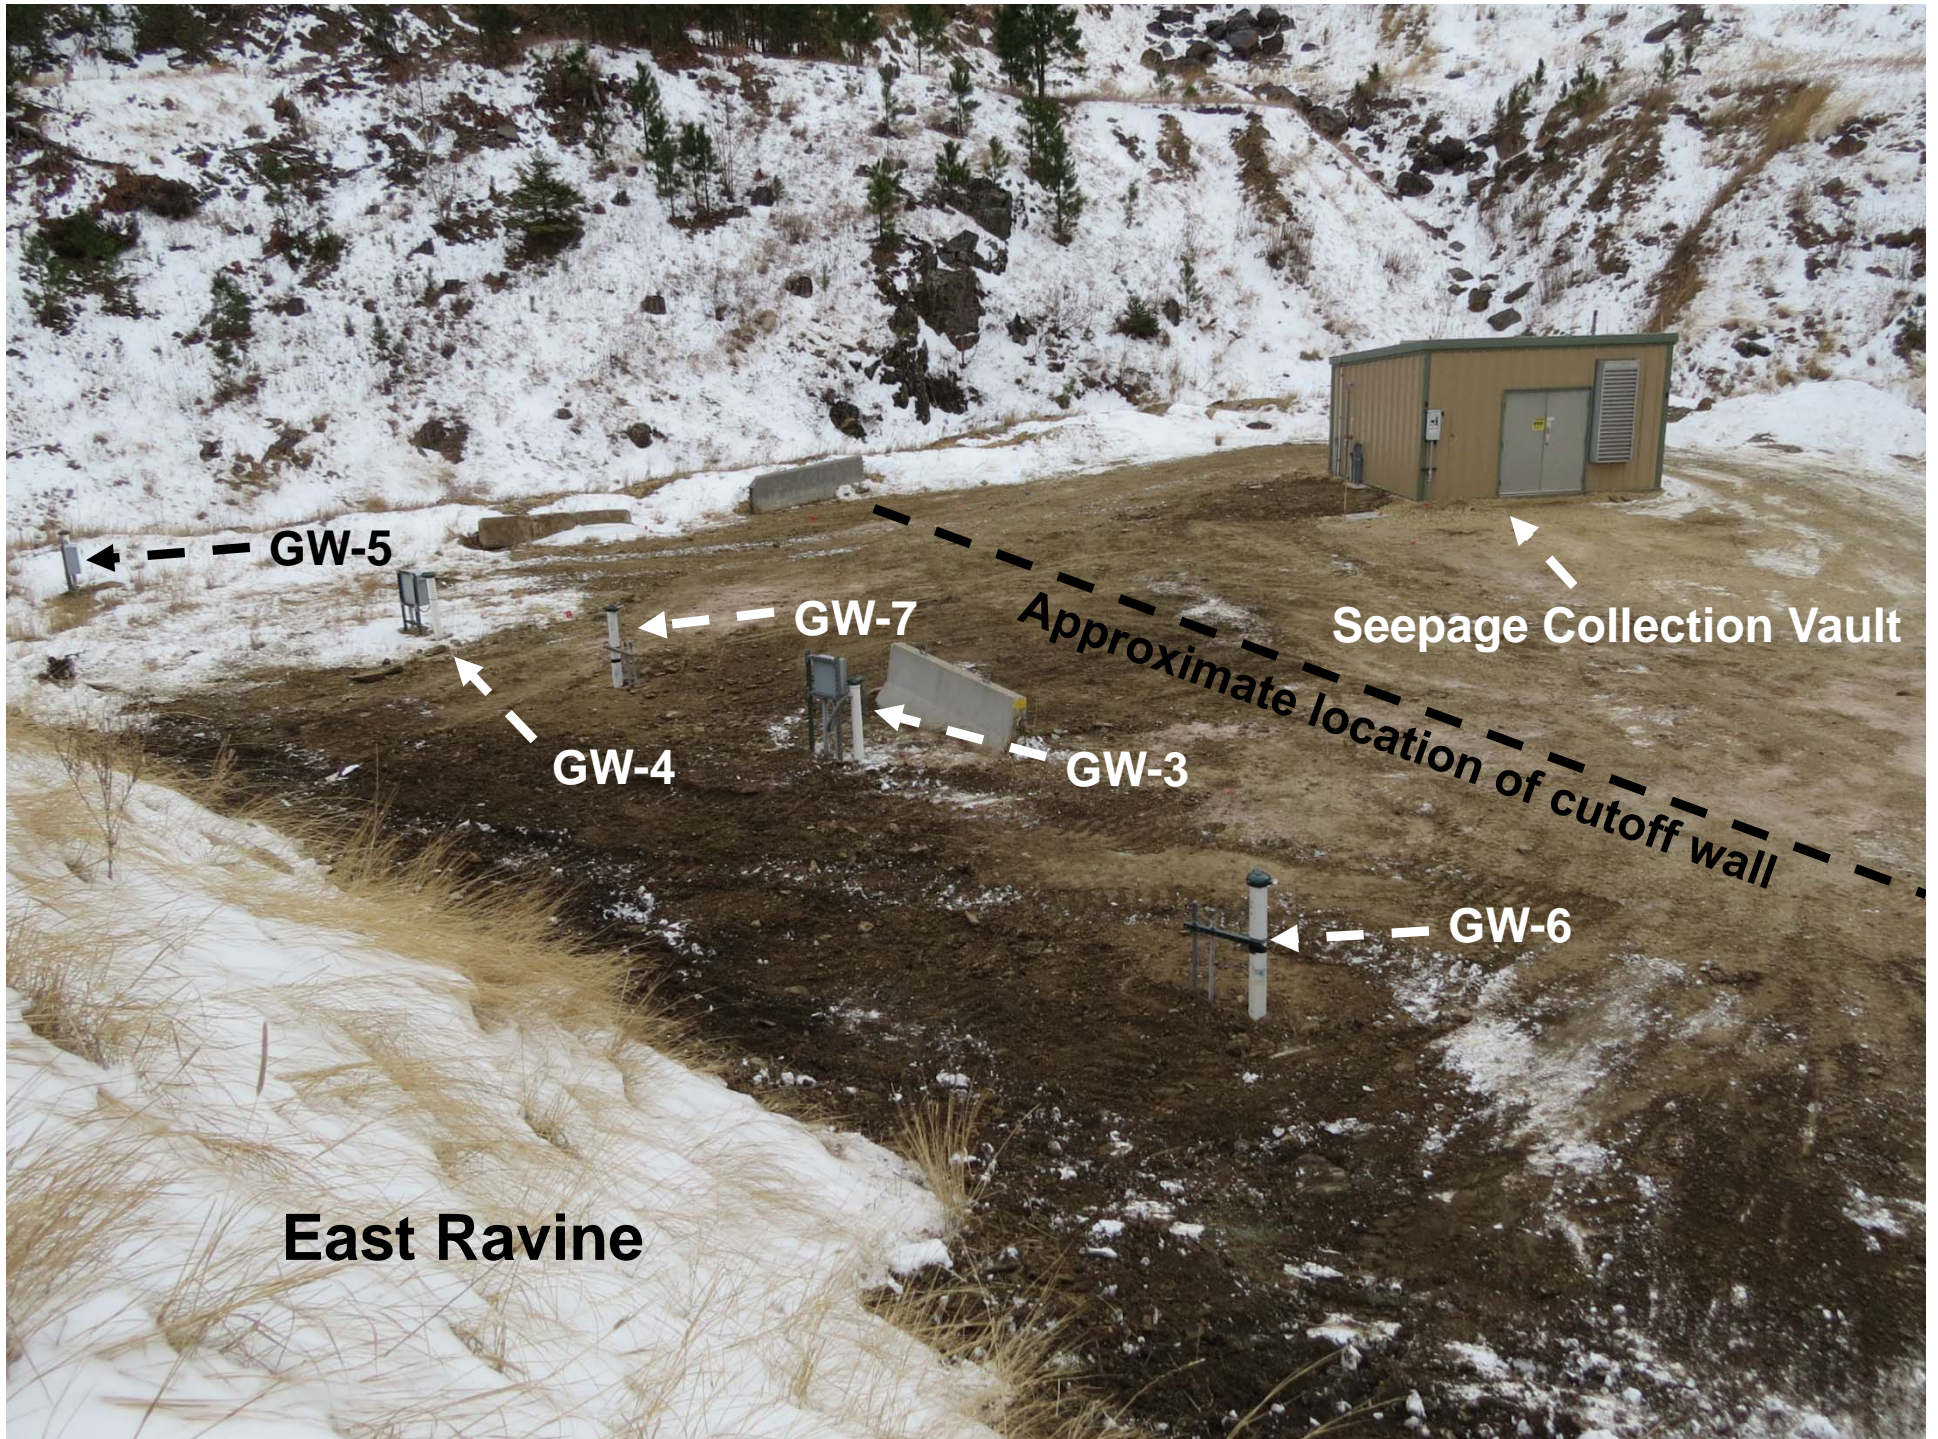
- Three wells were drilled to intercept potential source in 2012 and 2013 (GW-3, GW-4 and GW-5)
- Pumps were installed to divert water into the collection system
- Results showed significant decreases in TR-Se, TDS and EC and very low flows at EWR-5
- Ave TR-Se: from 0.015 mg/L range to < 0.005 mg/L with occasional detectable levels
- Ave TDS: from 2550 mg/L range to 1200 mg/L
- Ave EC: from 2850  $\mu$ mhos range to 1530  $\mu$ mhos

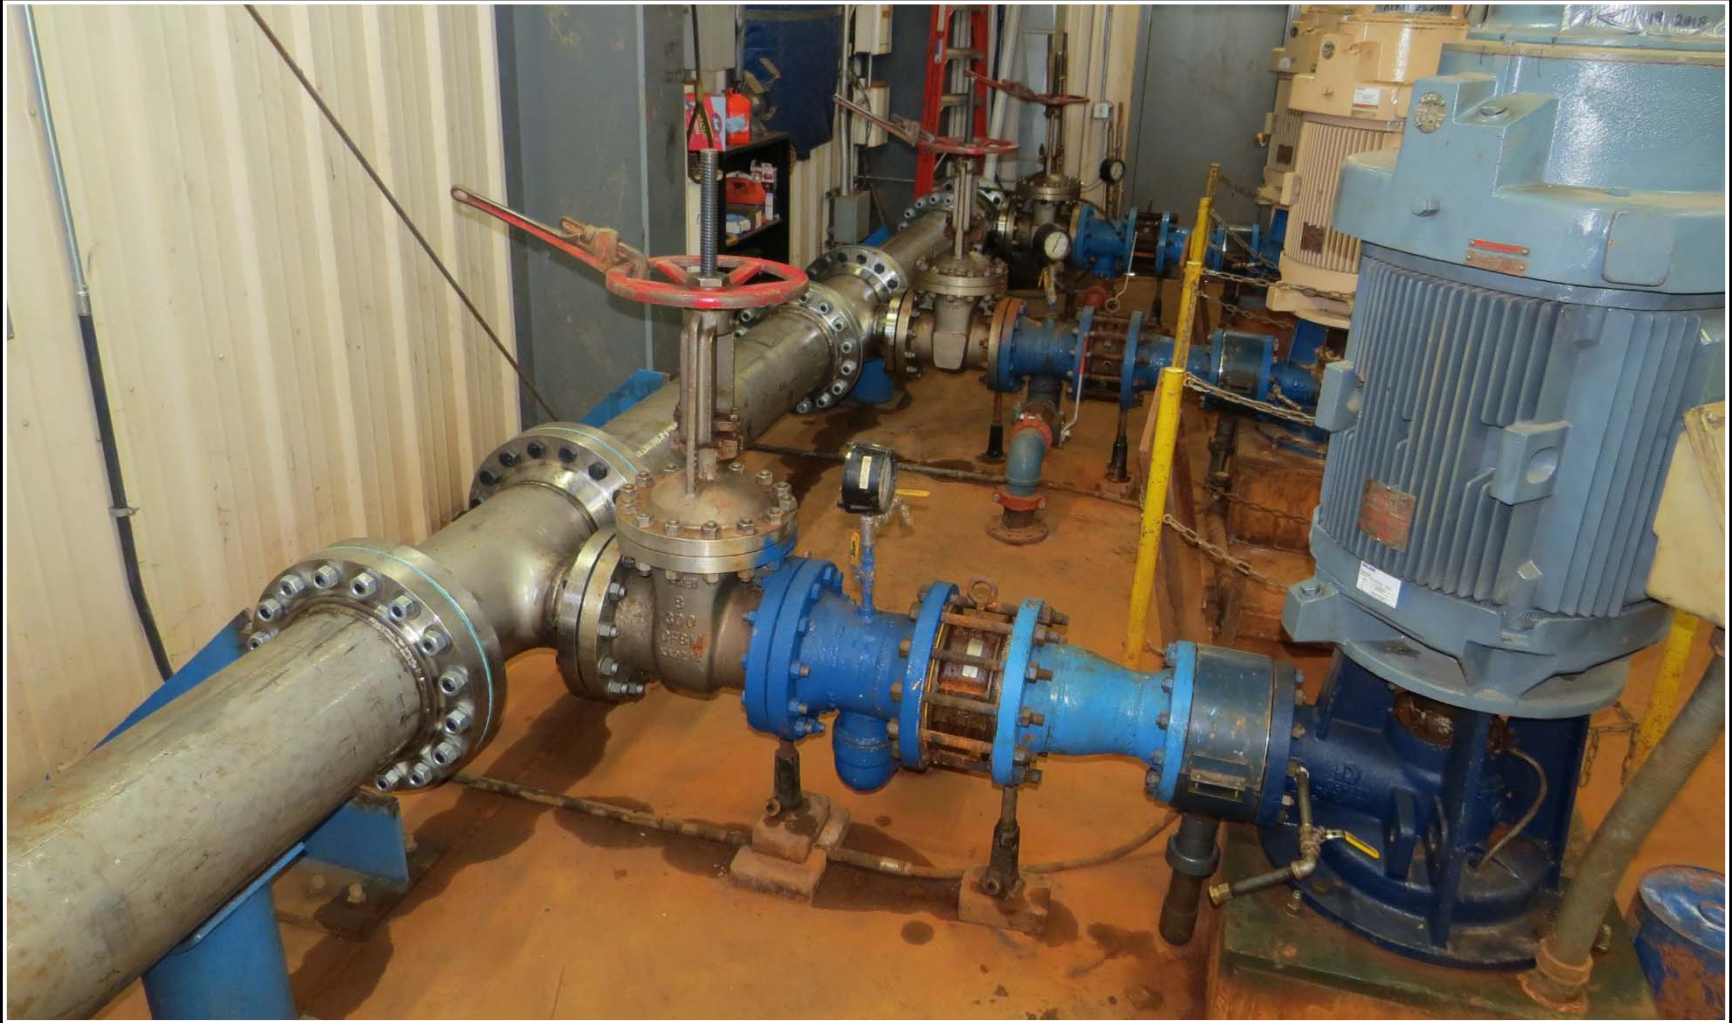
- Stainless steel pump header was installed in seepage collection building to connect the three pumps used to pump seepage back to tailings impoundment.
- 316 (grade) stainless is corrosion resistant and reduces iron buildup in pipes
- Stainless Steel or HDPE plastic piping used
- MCC replaced with digital MCC

**Stainless Steel Header at Seepage Collection**

- Complete transition to all stainless steel at GG seepage collection facility
- Continue Water Treatment Agreement with SDSTA
- Continue Water Treatment

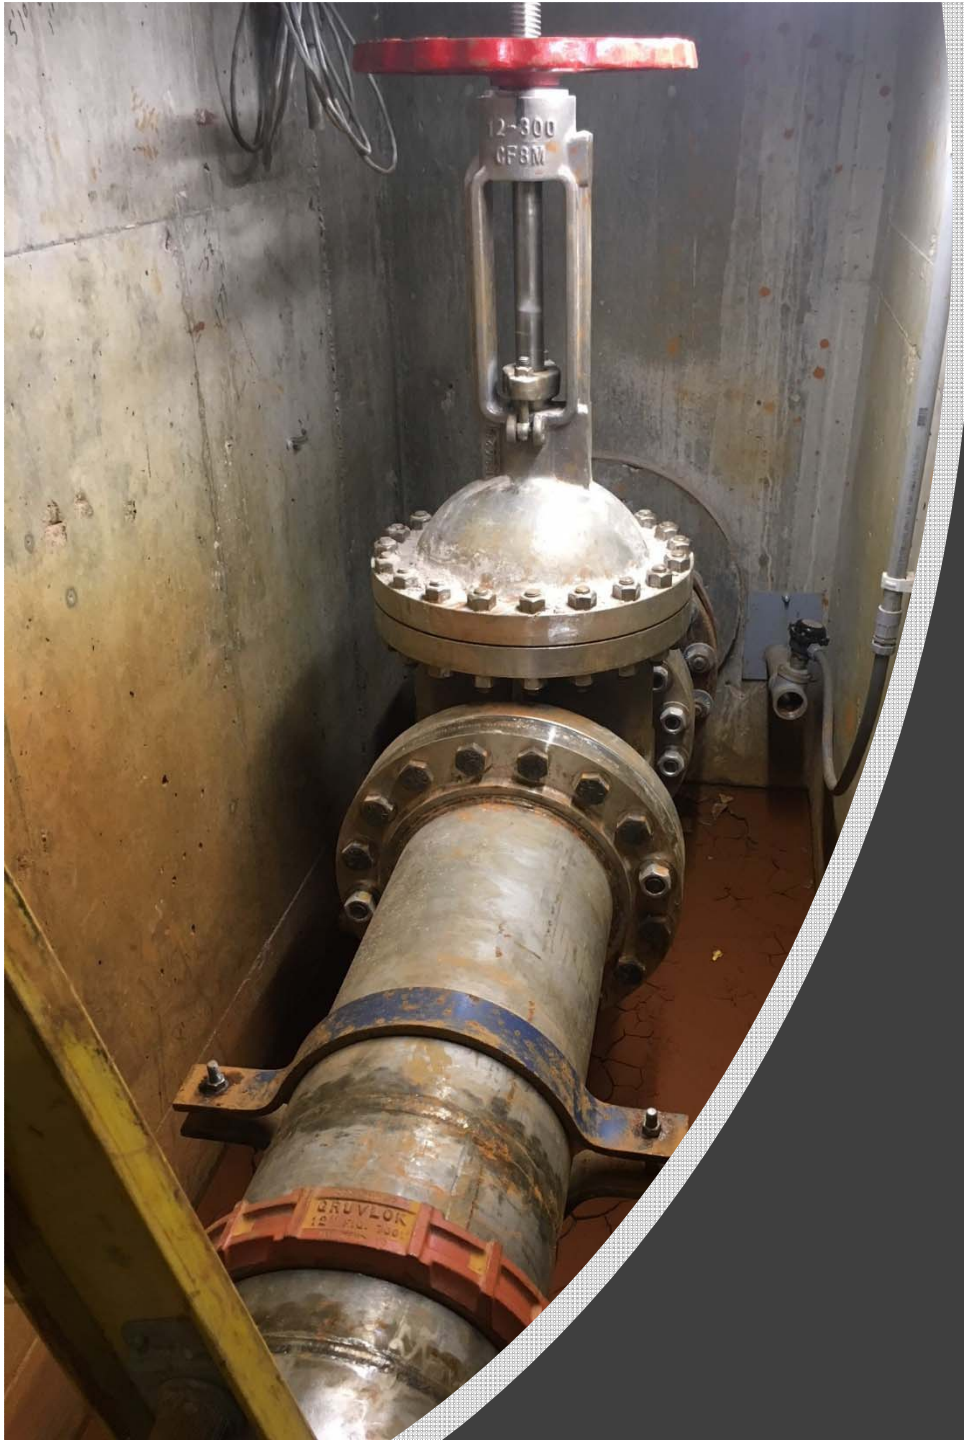
# Isolation Valve for Pump-back Line

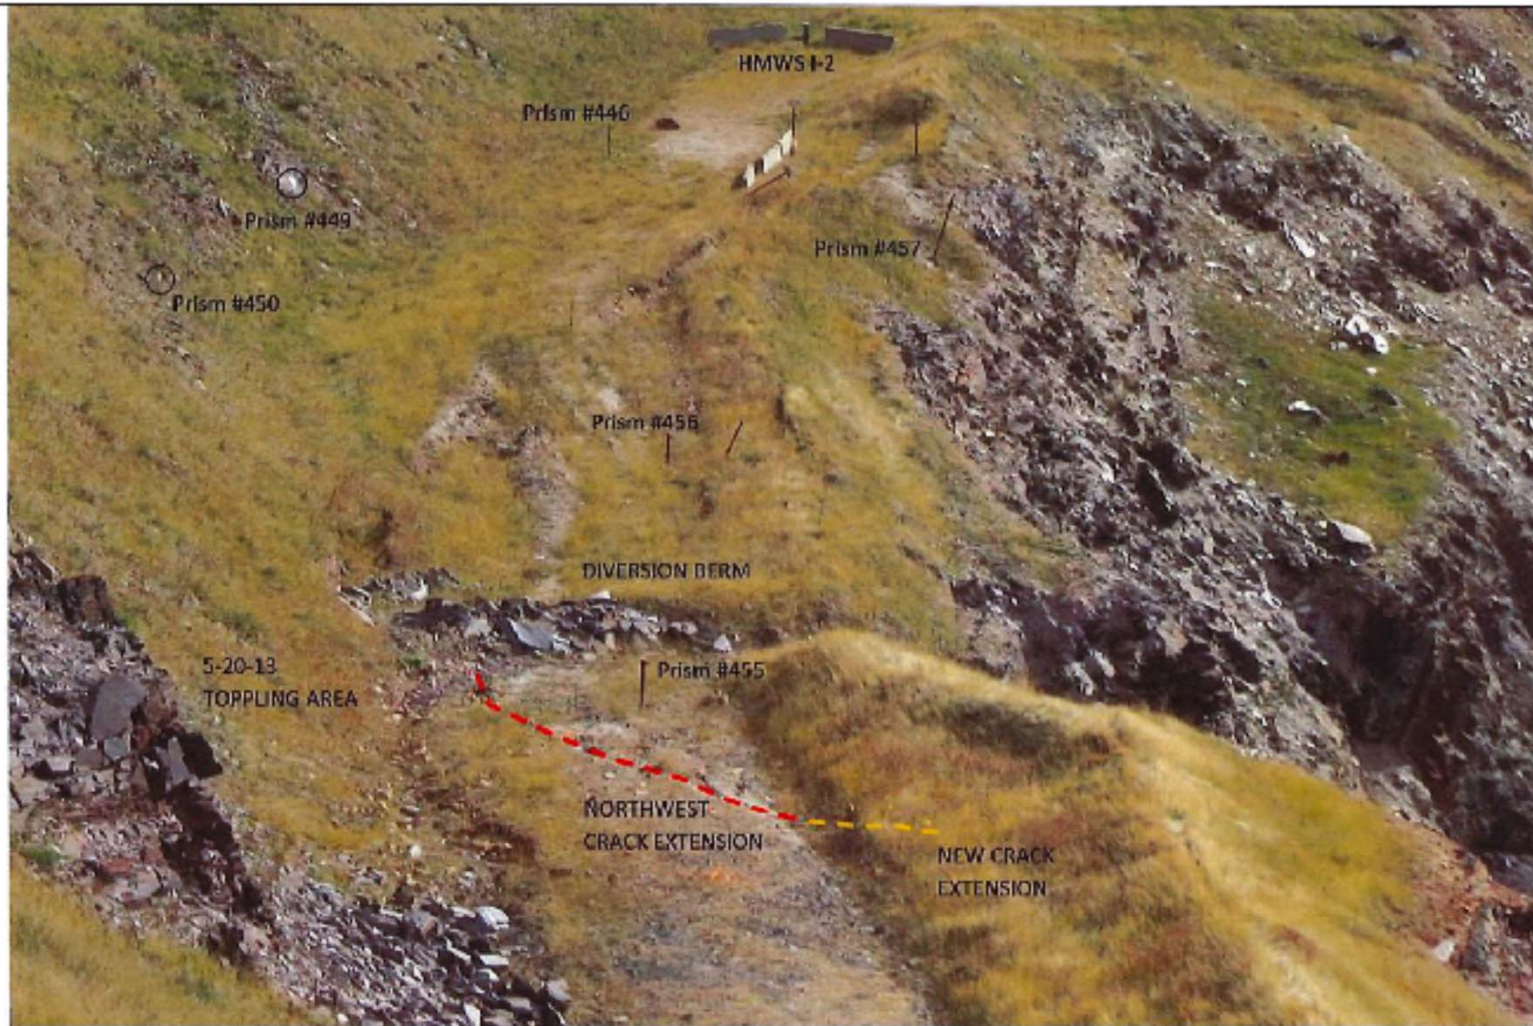
PHOTOGRAPH 2

**ACCESS ROAD MOVEMENTS: SE VIEW OF EAST BLOCK  
(PHOTOGRAPH TAKEN ON OCTOBER 23, 2018)**

- Open Cut East Block
  - Could still progress to failure
  - Failure would be contained within pit boundary on Homestake-controlled property

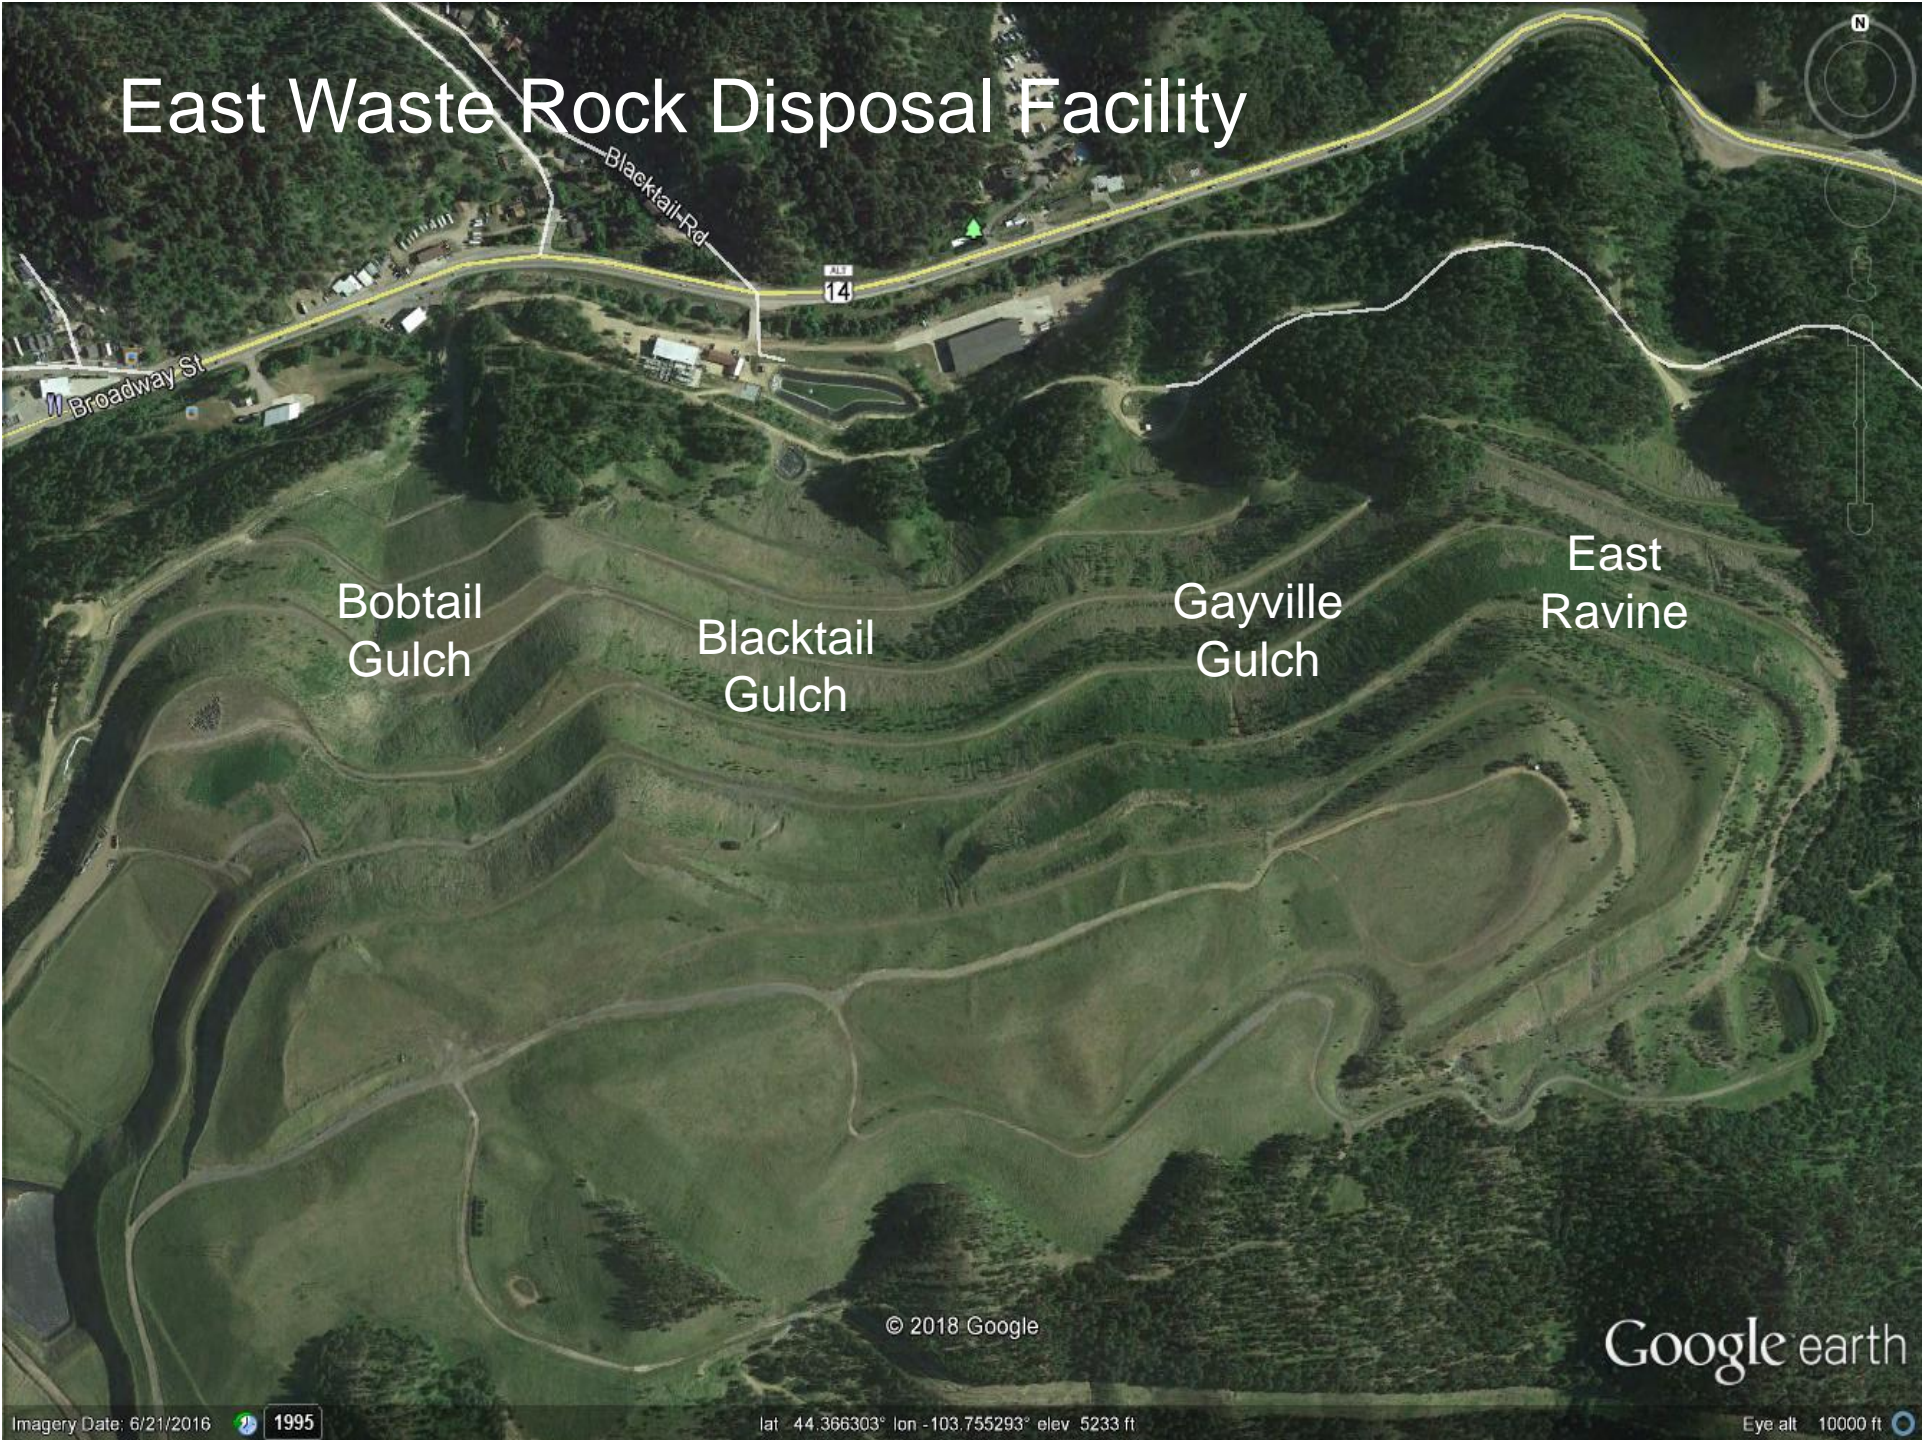
# East Waste Rock Disposal Facility

- East Waste Rock Facility - 2018  
(Blacktail, Gayville and East Ravine)
  - As previously reported, readings of some monument surveys subsequent to October 2015 show possible divergence from past monitoring trends.

Bobtail  
Gulch

Blacktail  
Gulch

- East Waste Rock Facility - 2018  
(Blacktail, Gayville and East Ravine)
  - Homestake has employed multiple displacement monitoring techniques to better evaluate the EWRF and determine the cause of the apparent divergence
    - Survey Monuments
    - Piezometers
    - Inclinometers
    - Visual Inspections
    - Drone surveys - **new**
    - Migrated to InSAR Monitoring - **new**

- East Waste Rock Facility  
(Blacktail, Gayville and East Ravine)
  - Additional ongoing work:
    - Perform base station surveys before each biannual monitoring review to measure any movement of base stations
    - Inspect benches and slopes bimonthly, as weather allows
    - Visually monitor the tension crack at the crest of the 5100 Bench in Gayville Gulch at least quarterly

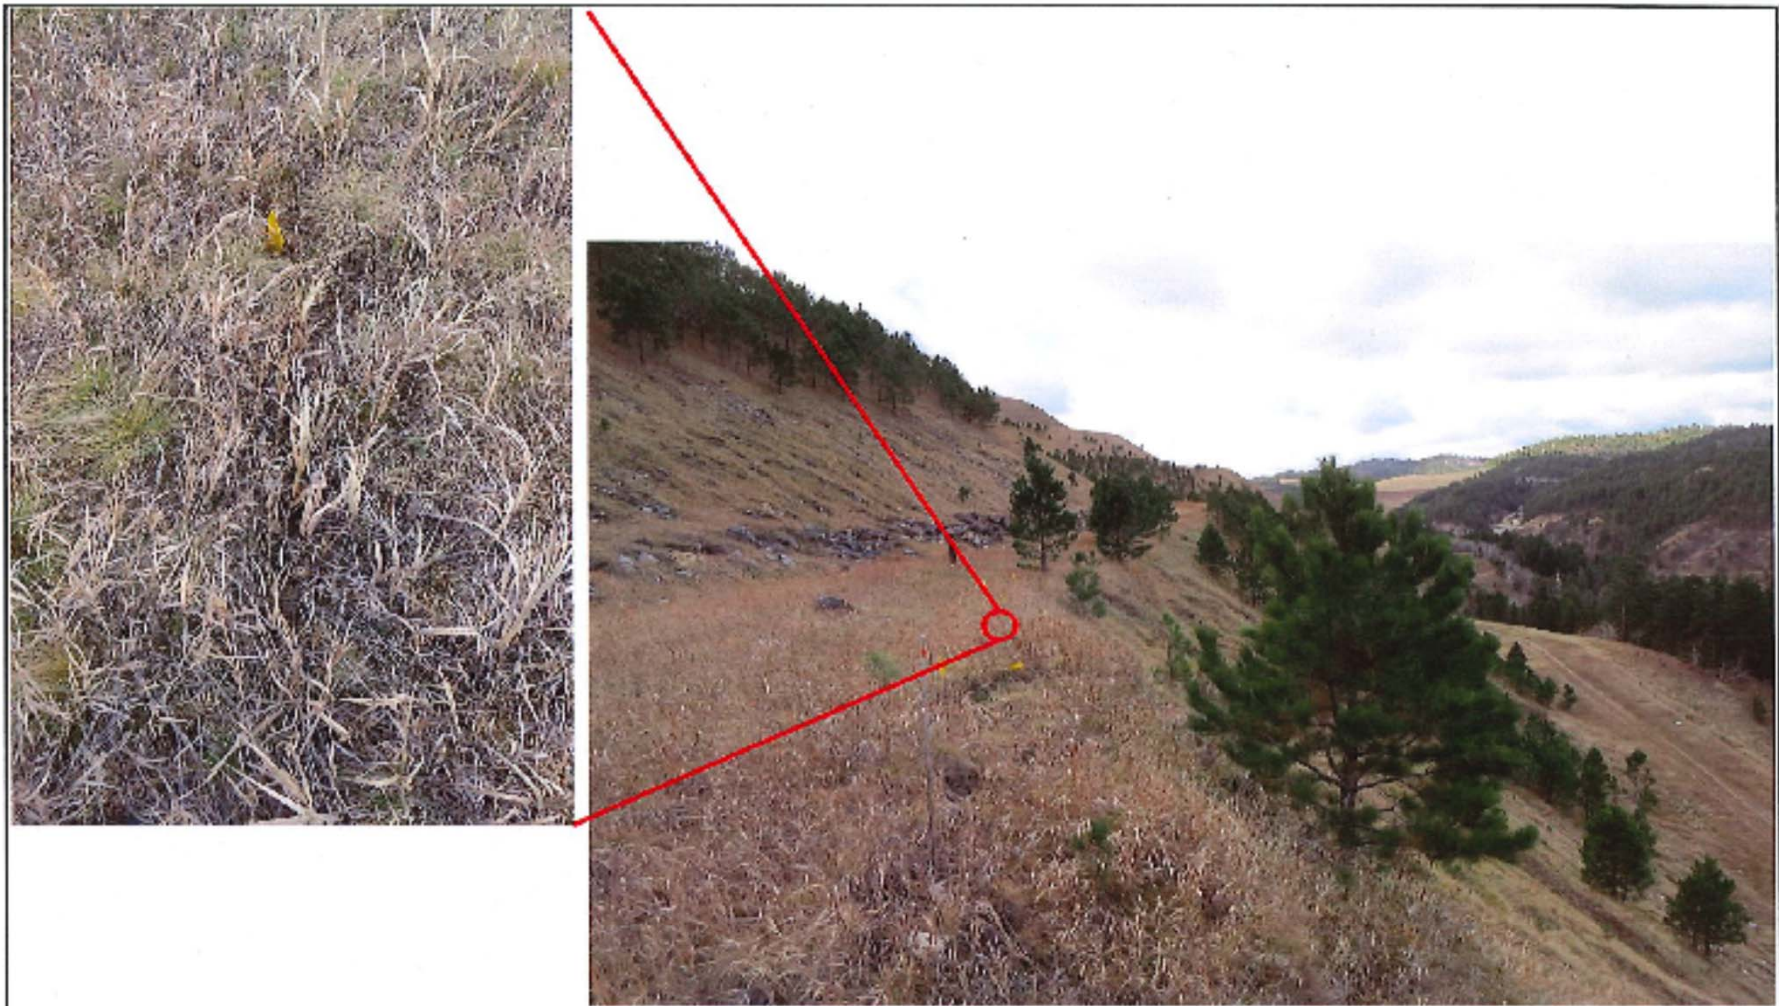
<b>DECEMBER 2018 SEMI-ANNUAL GEOTECHNICAL MONITORING REPORT LEAD, SOUTH DAKOTA</b>	<small>DRAWN</small> <b>AJS</b>	<small>DATE</small> <b>11/06/2018</b>	<small>JOB NO.</small> <b>1898060.200</b>
		<small>FOR</small> <b>GL</b>	<small>FILE NO.</small>	<b>PHOTOGRAPH 5</b>

**TENSION CRACK AT THE CREST OF THE 5100 BENCH IN GAYVILLE GULCH LOOKING WEST  
(PHOTOGRAPH TAKEN ON OCTOBER 30, 2018)**

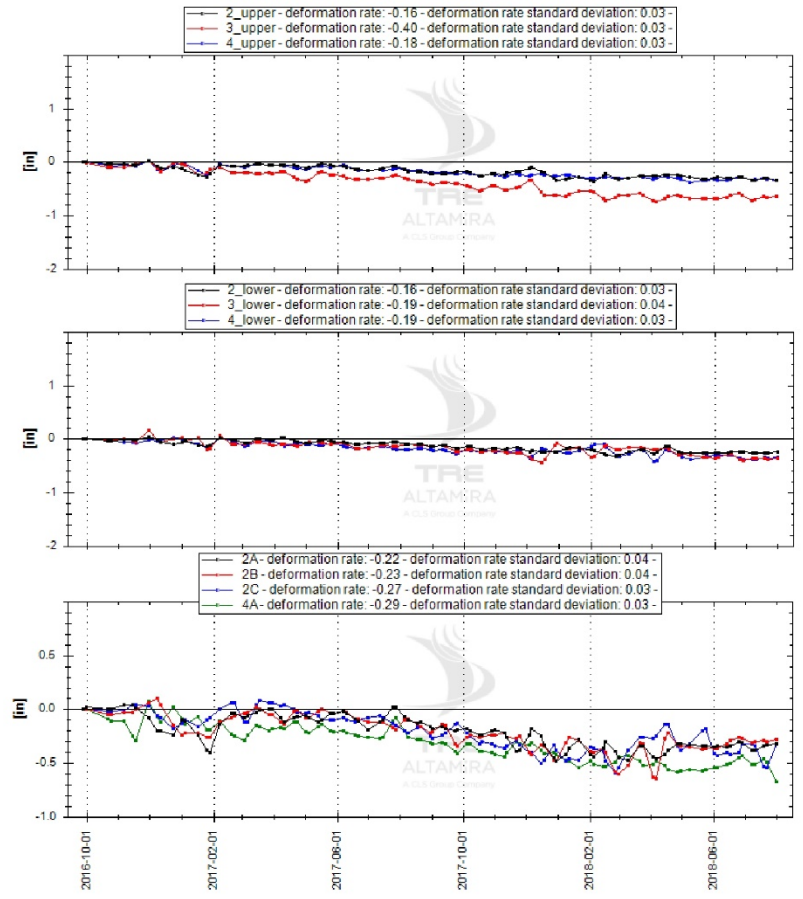
- Data for the Homestake Mine was evaluated for historic and current data.
- Data indicates that Blacktail, Gayville and East Ravine are behaving as expected
- No areas of concern were noted at the open cut, waste rock facilities or tailings dam.

**SqueeSAR® Analysis**  
**Sentinel Vertical**  
**Sep 2016 - Aug 2018**
