**SUBJECT:** Observation Tour Review

**Britton Line**

### **Napa–Platte Line**

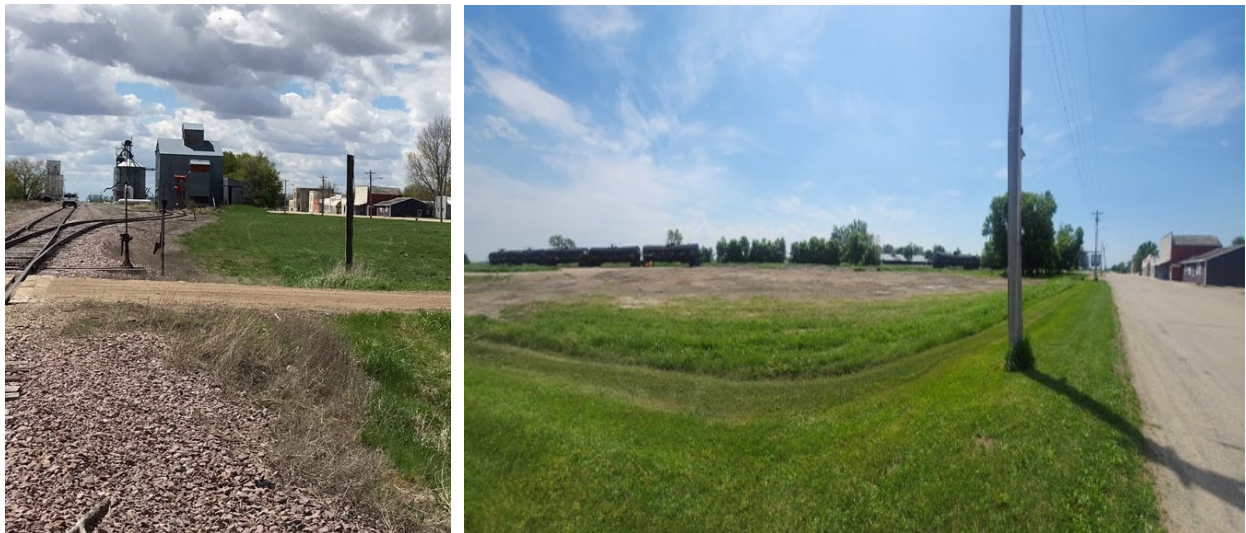
- Claremont (Animal Fat Transload Site and Elevator): Minor oil spots were observed on the gravel road, with no odor. Around 10 railcars were parked on the siding.
- The adjacent old grain elevator had been breached for grain removal, but demolition had not started at the time of observation tour. Demolition was completed in the week of May 11, 2026.

Above are before and after pictures of the Claremont Elevator site.

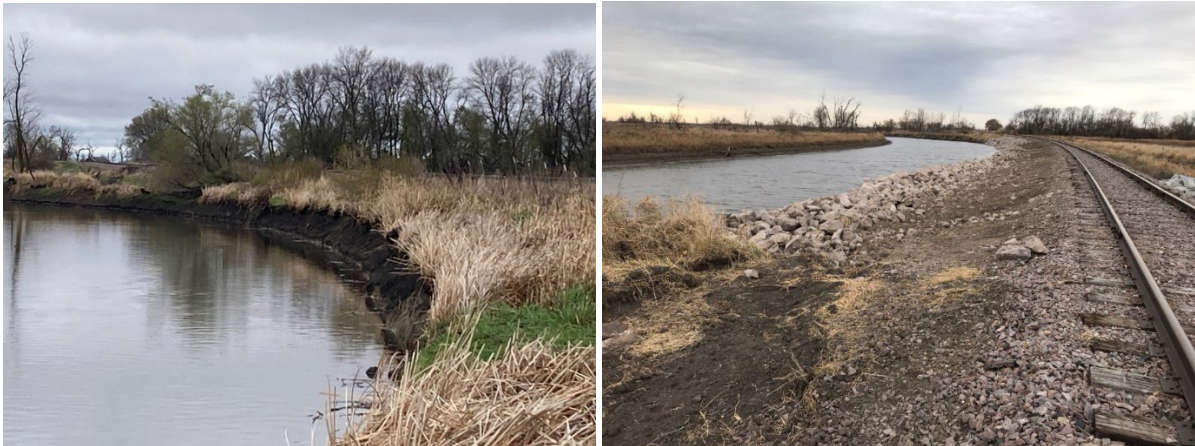
James River near Tacoma Park: The river's encroachment has been addressed by placing rip rap to stabilize the riverbank. The bank remains close to the rail bed, but there is no evidence of recent erosion or further encroachment. Below are the before and after pictures:

James River site before and after pictures.

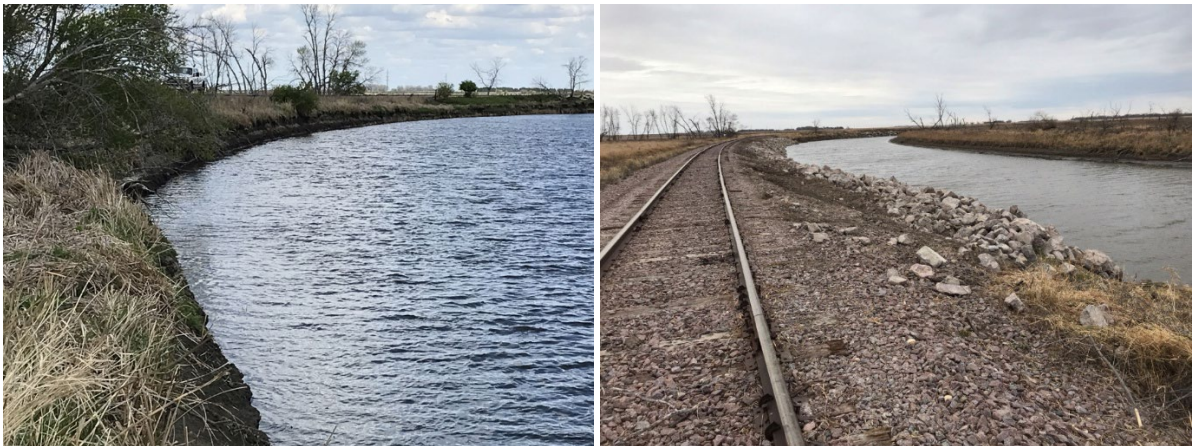
Eastward facing.

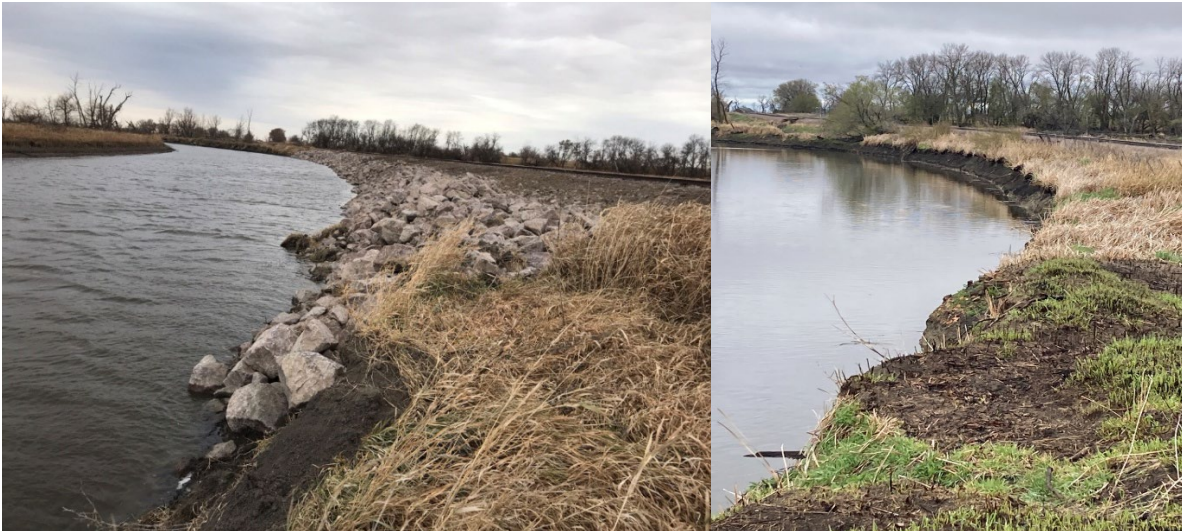
Northwestward facing

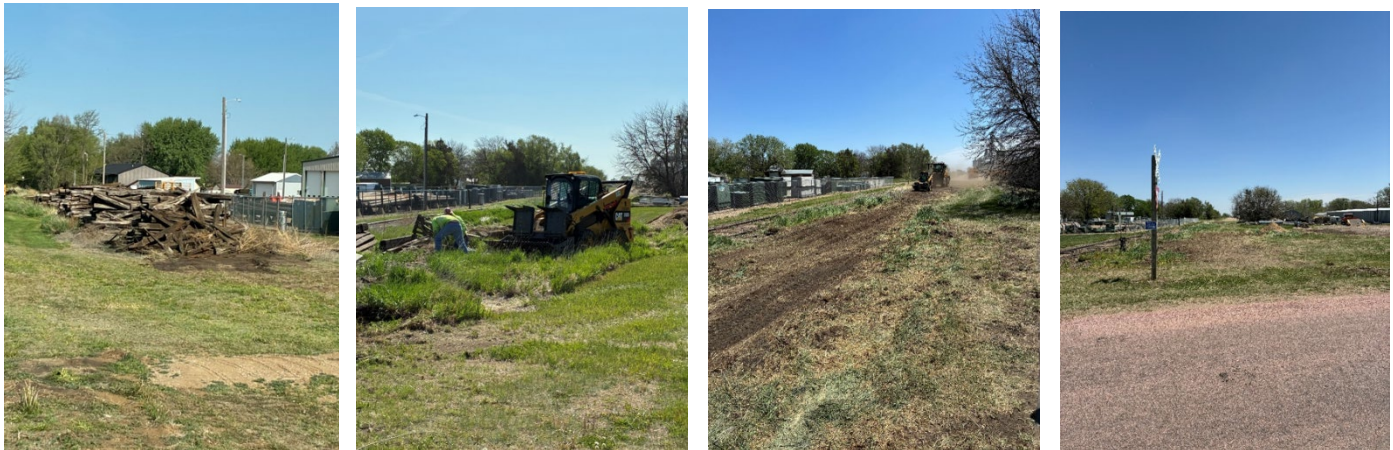
- **Track condition:** Generally good for its age, though old ties remain scattered in ditches, and the Town of Tabor requested removal of a pile of old ties within city limits.

Below are the before and after pictures of the Tabor tie and OTM cleanup.

- SDDOT Yankton Region and the Office of Air, Rail, and Transit collaborated on the cleanup of old railroad ties and OTM in Tabor in January 2026, with cleanup activities completed on May 12, 2026.

- The Yankton Region coordinated efforts with the City of Tabor, and removed all scrap ties and OTM, back dragged the area, and planted grass seed. The project resulted in receiving a check for \$2,535 for scrap metal and scale tickets totaling \$3,398.40 for removal costs.

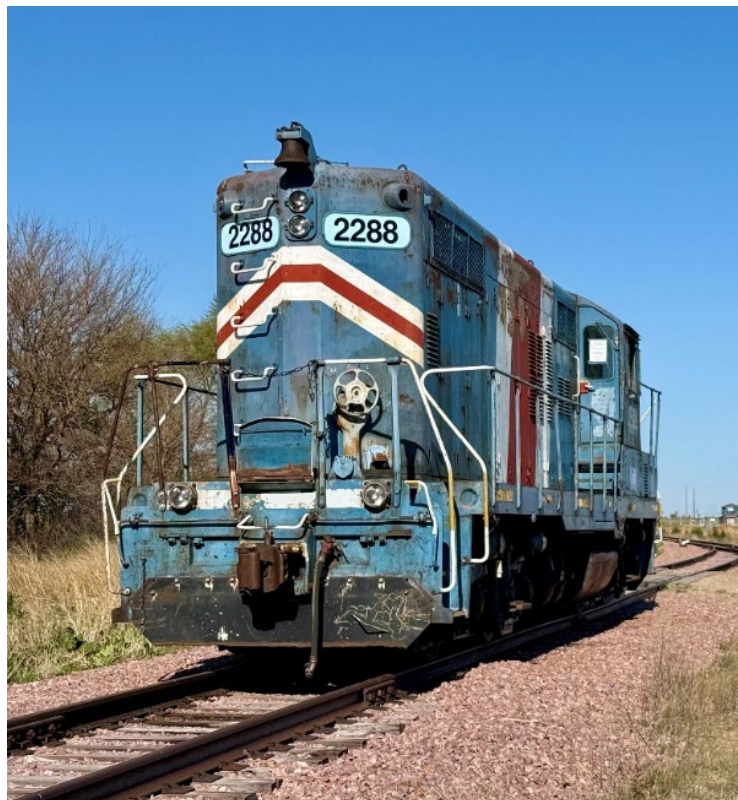
Napa Junction: Rock Island's Locomotive at Napa Junction removed.

- Rock Island purchased Locomotive SPTX 2288 from Dakota Southern who had it stored on state owned rail line at Napa Junction since 2024.
- With help from Board member Lockwood, staff coordinated with Rock Island and BNSF to have the locomotive removed from state owned rail line.

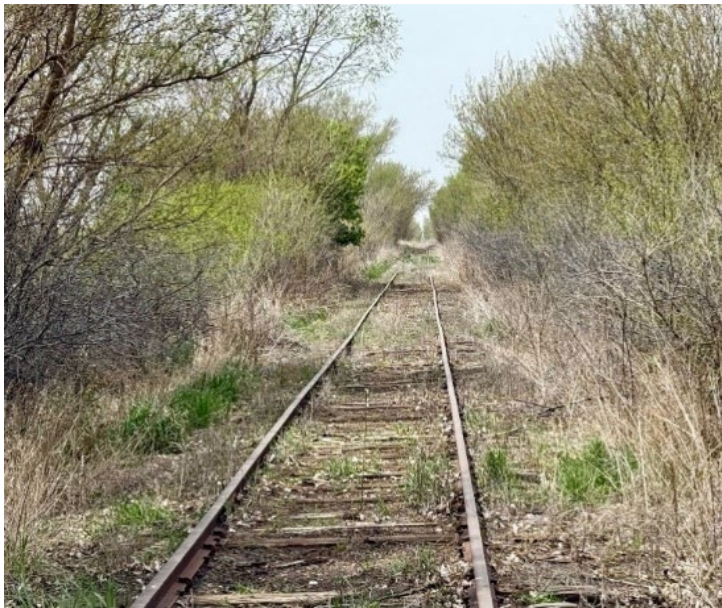
Napa to Platte: Some areas with encroaching brush.

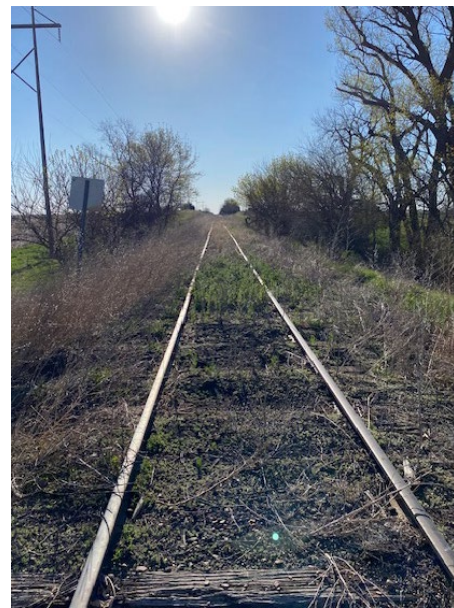
- **Vegetation:** The corridor from Napa to Tabor was full of dead weeds from previous summer. Some tall bushes and trees remained but did not interfere with the hi-rail vehicle. A new crop of thistles was noted in familiar locations. Weed spraying operations were completed by Dakota Helicopters June 26, 2026. The weed spraying was effective.

Napa to Tabor: Several areas with weed overgrowth.

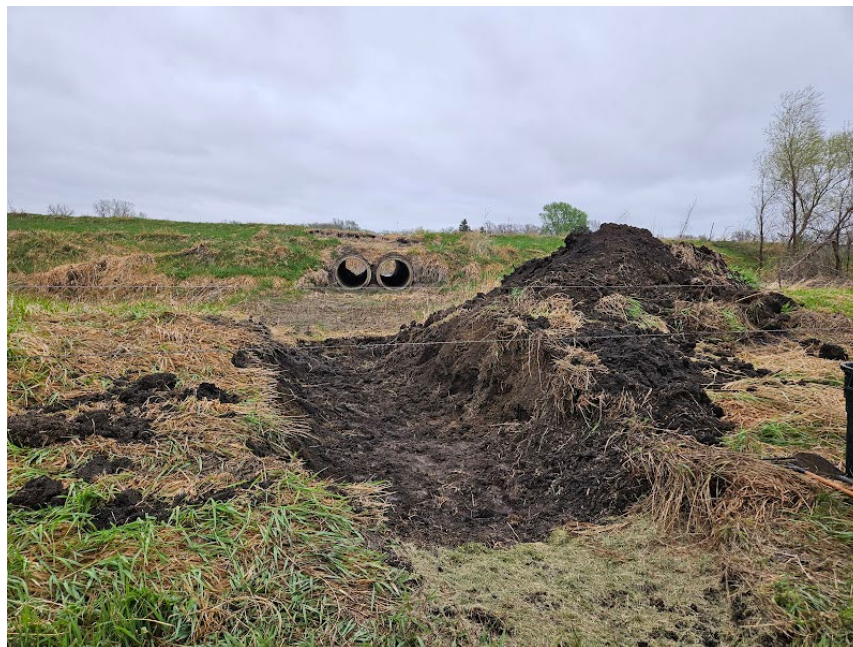
Napa to Platte: Trenched berm outside of Tyndall.
